MINI Cooper - Leaking coolant

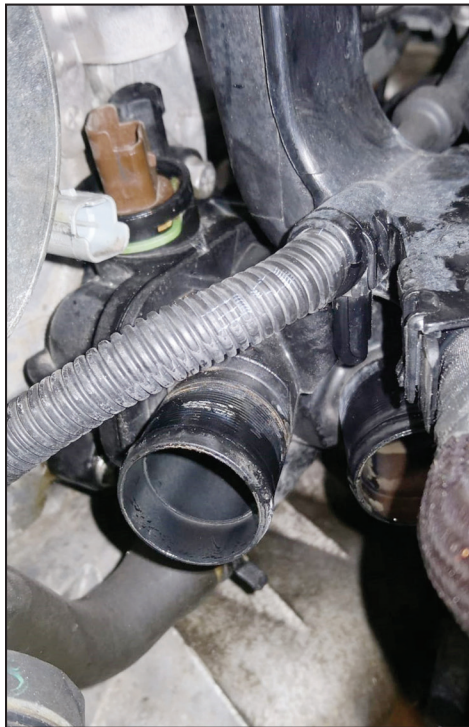
The housing is quite tricky to access and it is always best to fit a new unit to prevent any further issues

Her delight soured a little when she got to me and I went to have a look at the engine, as I opened the bonnet a small cloud of steam escaped. I could see the disheartened look on her face. Reassuring her that this may not be serious, I had a closer look at the area the steam was coming from, and saw that it was from around the thermostat housing. The large plastic unit was leaking around the seal, and I knew from past experience that once these housings begin to leak, they are either distorted or cracked and the only answer is to fit a new unit.
