# Opel Astra - Common link arm knock

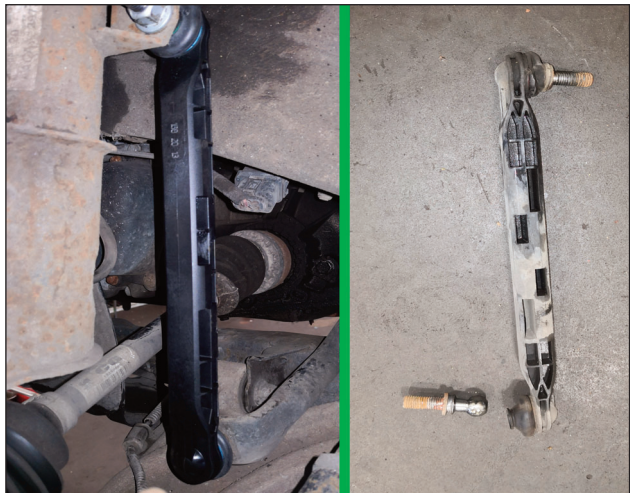
**The wear in the ball joint allowed the arm to drop off on the journey to the garage, silencing the knocking noise**

The noise never returned and so he drove around quite happily until the NCT. It was then noted that the knocking had been a worn ball joint on the antiroll bar link arm. This has now popped off and so the knocking had stopped.

This had obviously occurred on the way to the garage at the point the knocking had been silenced. The link arms are a very common problem and 80% of the front end knocking problems I see are from a worn antiroll bar link arm. A pair of new link arms was fitted and the motor was good to go.
