Opel Corsa - An easily fixed oil leak

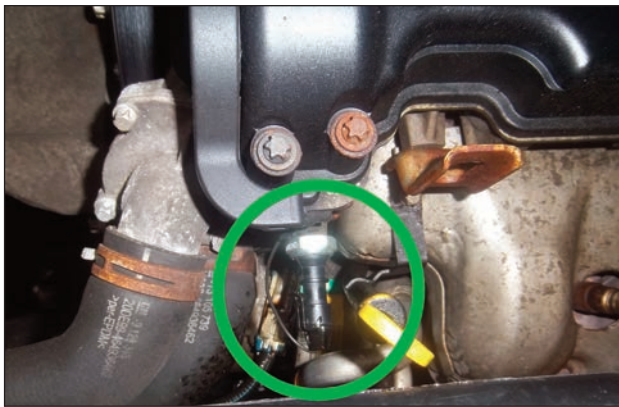
The leak on this 2005 Opel Corsa was not going to present a problem, and as soon as I lifted the bonnet I could see the oil dripping from the end of the oil pressure switch. Rarely is it so easy.

The source of the oil leak was spotted as soon as I looked under the bonnet and the oil pressure switch was easily replaced

The switch is also nicely accessible and so fitting the replacement was almost as quick, all that remained was for the oil to be topped up and the residue down the front of the engine to be cleaned away.
