# PEUGEOT 207 - Clutch clearance trouble

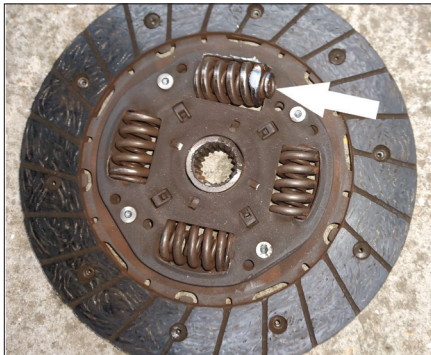
**One of the centre plate springs had broke loose and was interfering with the clutch**

Once the gearbox was out, it was found that one of the springs in the clutch friction plate had begun to break free, and was now dragging on the underside of the pressure plate springs. This was the source of the screeching sound and the reason for the ineffective operation of the clutch.

With the new clutch in place, all of the problems sorted out.
