Tech Bits with Tim Stock

Silicate beads in coolant reservoir can clog a heater matrix

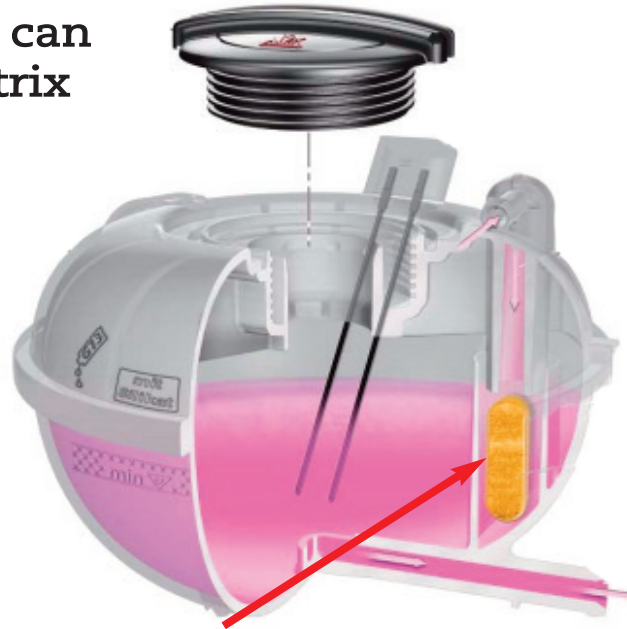
The silicate beads, (at arrow), can migrate to the heater matrix and cause blockages

The manufacturers installed a silicate bag inside the coolant expansion tank. Over time, the silicate beads are there to leach into the coolant to keep the corrosion protection at an acceptable level.

The heating problem occurs when these silicate beads migrate from the coolant tank and end up blocking the heater matrix,

resulting in loss of heating. This requires a great deal of repair time to replace the

matrix and clear the cooling and heating system of the contamination. Any beads left in the system could cause the replacement heater matrix to become blocked, resulting in the same problem.
