Suzuki Wagon R - Boot bother

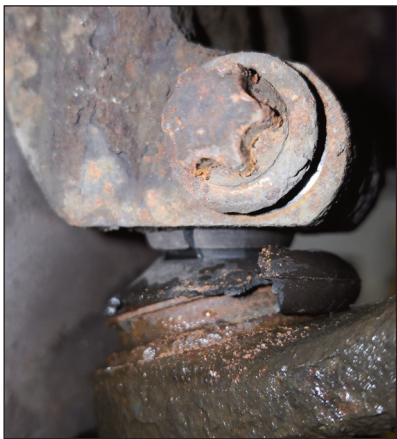
The perished rubber boot had allowed the dirt and grime from the road to enter the ball joint causing it to wear

When the next NCT test came around the rubber and boot had perished, and was now not protecting the lower ball joint. This had allowed grit and dirt from the roadway to enter the joint, which had consequently worn and now also needed replacing.

A new lower arm was needed, but of course I wasn't going to say I told you so. It is a fact a stitch in time saves nine!
