Ford C-MAX - Badly Twisted DMF

Hyundai Getz - Driveshaft Failure, Again

Fiat Seicento - Suicide Doors

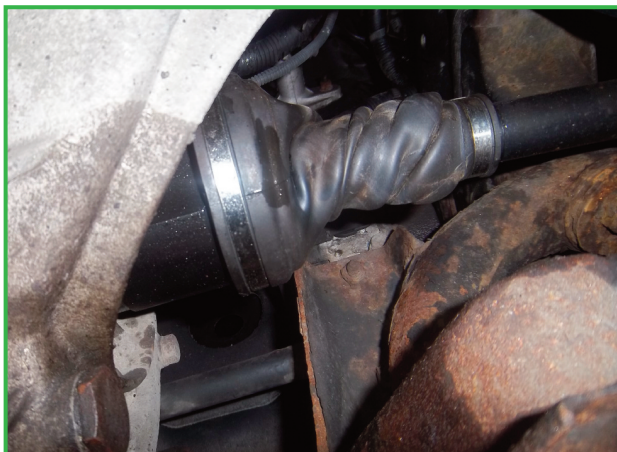
Now the owner decided that maybe we should have a look. We discovered that the new driveshaft that had been fitted had failed at the inner joint. The joint was spinning round in the gearbox, but the shaft wasn't moving. We have no idea where the shaft came from but the owner knew where it was going!

The new shaft had failed at the inner joint, spinning the boot up

This time we fitted a new shaft from a reputable manufacturer. The owner paid the surcharge due on the old unit so that we could give him the failed shaft.

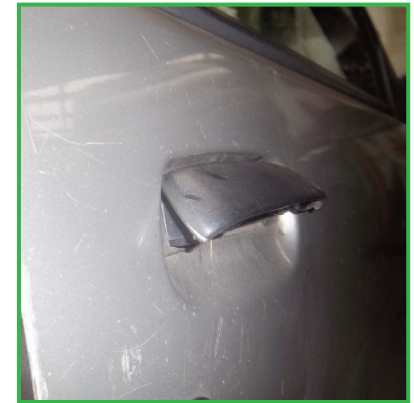
Staying in the up position when opening the door prevented the catch from operating correctly

The problem on this Fiat was that the driver's door exterior handle would stick up, when the door was opened. The term suicide door is normally associated with a door that is hinged at the back and so opens into the direction of travel. The owner of this Fiat thought the term was perfectly apt for his doors, because if he failed to push the handle down when opening the door, it would suddenly fly open when cornering.

The remedy was simple and just like the problem with the bonnet catch, lubrication was the answer. The door panel was removed to ensure all the mechanism was properly lubricated and lubricating from the inside also saved the mess of excess lubricant running down the outside of the door.

Once we were happy that the handle was operating correctly the door panel was replaced.
