# VW Caddy - A Very Solid Brake Pedal

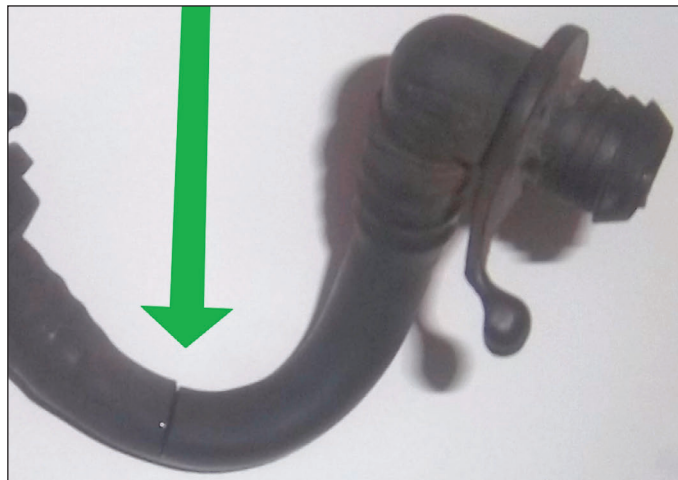
**The servo hose had cracked and failed allowing the air to leak into the system**

Having disconnected the pipe, we discovered that the pump was operating ok and producing a good vacuum. The problem was that the vacuum was not reaching the servo unit. A close inspection of the servo pipe revealed a small crack which as the engine moved, flexed the pipe and opened up the crack.

The new section of pipe was a lot cheaper than the pump would have been, pleasing the owner!
