# VW Lupo - Starting problems after service

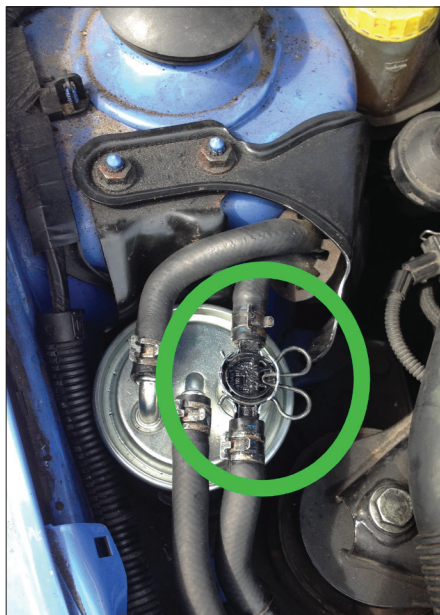
My first concern was that even after two weeks, there still appeared to be a light film of diesel around the top of the fuel filter. This would normally have been dispersed over that time, so I started by cleaning this thoroughly and then checking to see if there was any reappearance of the diesel.

After a short drive, I could see that the lightest film of diesel had indeed reappeared. I was pretty sure that if diesel was creeping out, air could just as easily be creeping in. The seals for the filter are available, but I thought changing the small T piece would be a better option. This is often supplied with the fuel filter, but hadn't been with this one.

**A weeping fuel filter seal was at the heart of the starting problems**

With the new T piece fitted, and the top of the filter cleaned again, the Lupo was given another run. This time the filter stayed dry, so the chances of the poor starting being cured were good.
