# VW Touareg – No socket cover

## Debris in the exposed socket caused the unit to short out

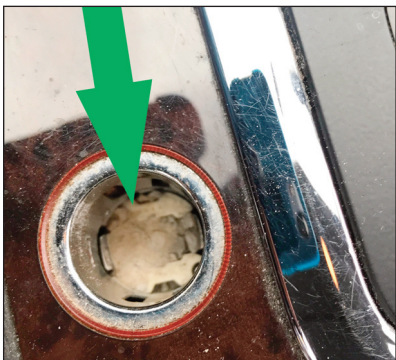
A quick peek into the exposed cigarette lighter socket soon revealed the problem. With the lighter unit constantly being left out, small bits and items loose in the vehicle, and there was quite a bit, found their way into the lighter socket and had shorted out the terminals in the socket.

After blowing the debris out using an airline, the socket was cleaned using an electrical switch cleaning spray. The fuse could now be replaced without blowing. I also found a plastic cover to fit over the outlet when not in use to prevent a reoccurrence of the problem.
