VW Touran - Insecure door panel

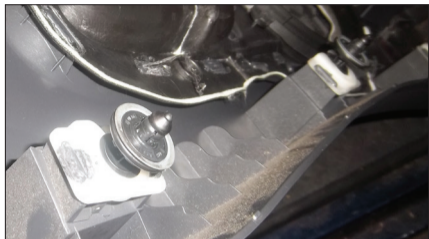
With new poppers, the panel then went back into place firmly and properly

Although the door panel poppers can normally be re-used, unless they are positioned correctly or if they have become brittle, this is not always the case.
