# VW Golf MK VII - Coolant level warning

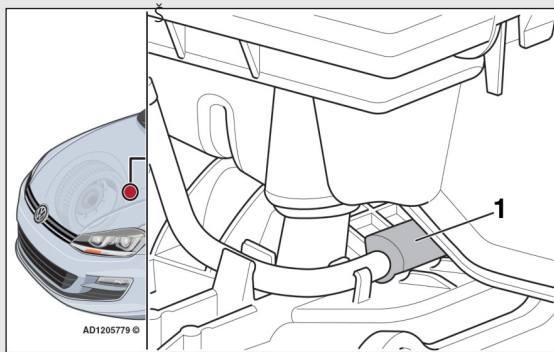
**Answer:** Yes, we have come across this fault before and it affects Polo, Golf and Jetta models with CJZA/CJZB/CJZC/CJZD engine codes. The engine coolant leak is due to a coolant pipe chafed through on the air filter housing. Fit a modified engine coolant pipe,

complete with protective sleeve, available from Volkswagen parts department Fig.1.1. The protective sleeve will prevent recurrence of the fault. Ensure engine coolant level and anti-freeze content are correct.
