# Blue Print ADG030148, ADG030149, ADB113012

To fit:  
BMW MINI 1.4i, 1.6i and 1.4TD 2001 > 2008

## Clutch kit

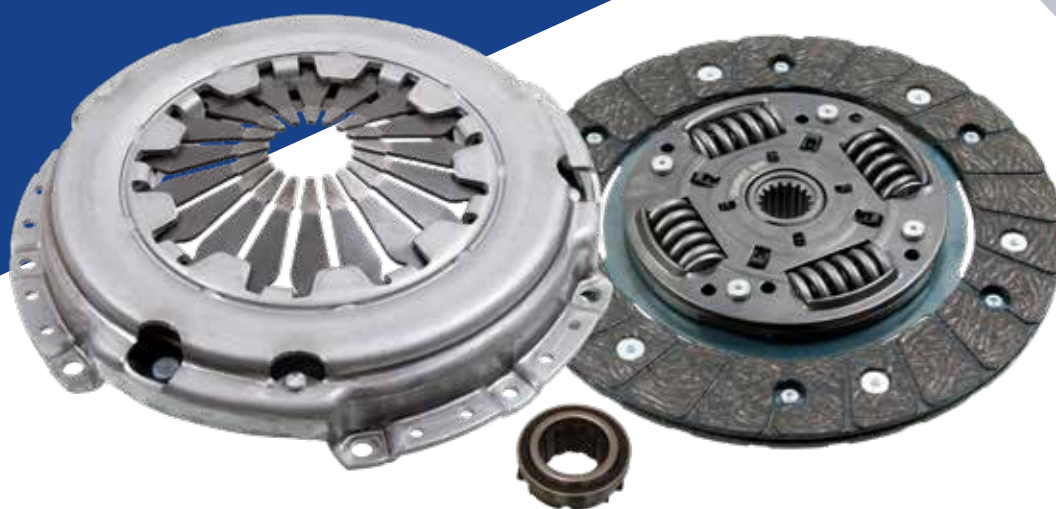
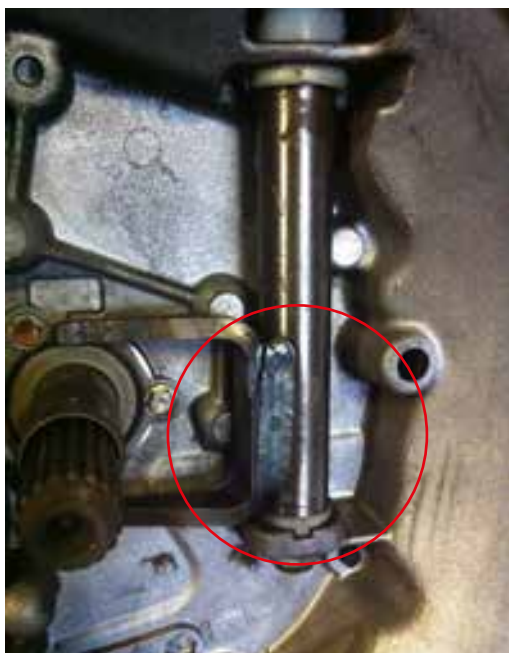
The vehicle exhibits symptoms such as the clutch not engaging, difficult gear selection and clutch 'judder'.

The welded area on the clutch fork can fracture. This allows the clutch fork to flex during operation, preventing the clutch from fully engaging. (Fig.1)

It is imperative that the clutch fork and the guide tube are cleaned and thoroughly inspected for fatigue or damage when the transmission is removed as part of a clutch replacement.

It is recommended that the clutch fork is replaced at the same time as the clutch, because the fork failure is a known issue with the MINI models listed above. Failure to identify and replace a faulty fork can cause clearance problems and difficulty in selecting gears. It is also recommended that the fork pivot bushes and locking pin are renewed at the same time.
