Jim Investigates...

Mazda 5 DPF issue

Written by Jim Gilmour Blue Print's Technical Consultant.

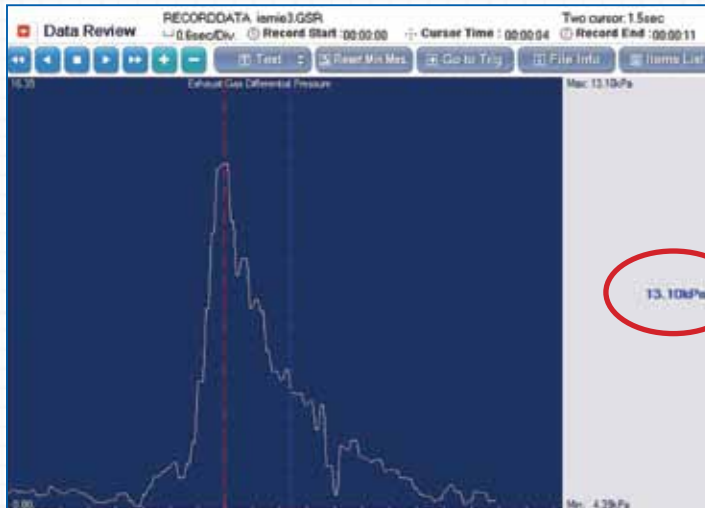
Firstly below is a graph of a known good DPF I had made and stored on the G-Scan for comparison – this is another nice feature of the G-Scan:

A typical value at idle would be around 0.5kPa (5mbar) rising to around 3kPa (30mbar) at 4,500rpm.

In this case the data was recorded during acceleration in order to condense it. This increased the maximum back pressure and when compared with a reading from a known good DPF, it gave us an instant comparison and an indication of how blocked the DPF was.

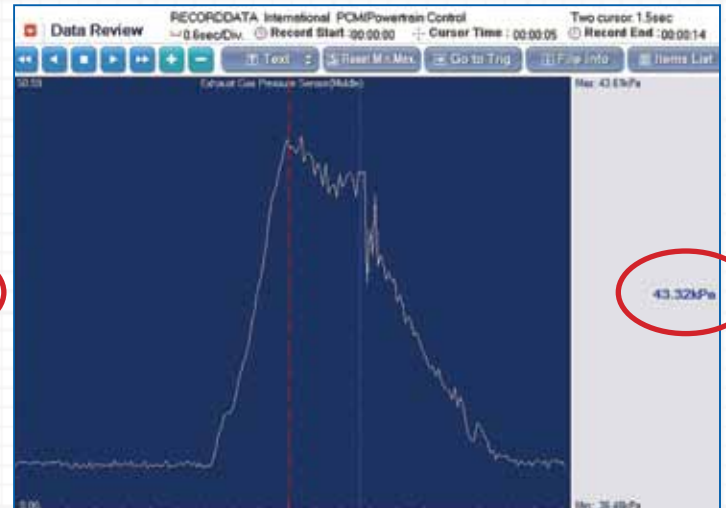
Now let's look at what our troublesome Mazda produced:

The idle differential pressure (Δp) at idle was more than 10 times that of a known good DPF at 5.9kPa (59mbar) and maximum Δp is 43.61kPa (436mbar), more than 3 times the pressure of a known good DPF.

As illustrated the (Δp) is very high and indicates a blocked DPF, we can also see that the pressure stays higher for longer on the blocked DPF.

The most obvious reason for the DPF failure was the type of journeys the driver made but it is never smart to be complacent. Further investigation into the operation of the other systems would have to be made.

From previous experience with this degree of clogging it was unlikely that the ECM's software would allow a forced regeneration and this was the case. Forced regeneration is not something that should be done without due consideration because it puts the exhaust system under high thermal stress and can damage components. Some manufacturers have removed the ability to do this from their scan tool's special functions.

The technician decided to fit a new Blue Print DPF and use his G-Scan to reset the ECU. Only when this was done could he check the operation and condition of the EGR, Air Mass Meter and engine temperature etc, which, to all indications were performing correctly.
