MINI radiator fan failure

The radiator fan resistor on the BMW Mini (2001 - 2006) can fail, resulting in one or both of the fan speeds no longer working, potentially causing overheating issues. Blue Print explains the steps to fix this problem.

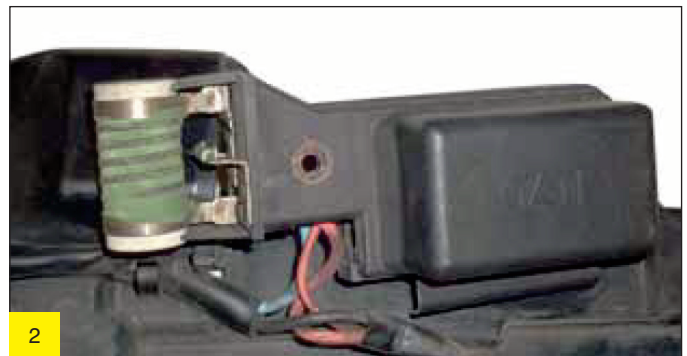
Once removed, you will see the resistor pack on the top of the cowling, which is held on by two 8mm screws. (Figure 1)

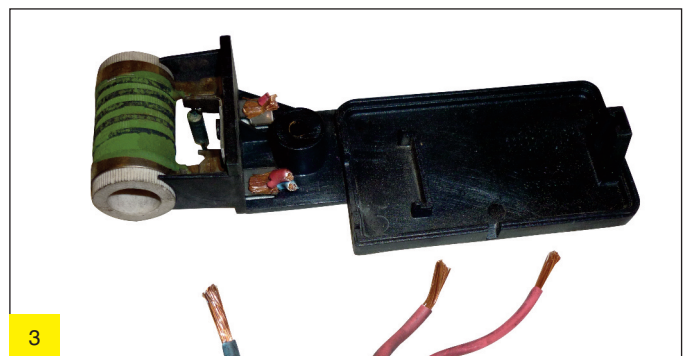
Remove the two screws to release the resistor pack and then remove its cover. (Figure 2)

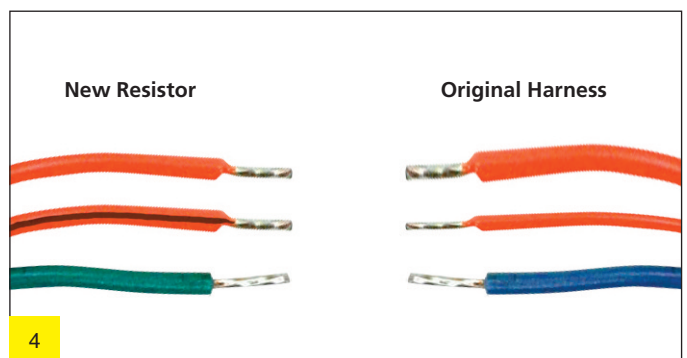
Next, cut the three wires as close to the terminals as possible and strip the ends of the wires ready for connecting to the new

resistor pack. (Figure 3)

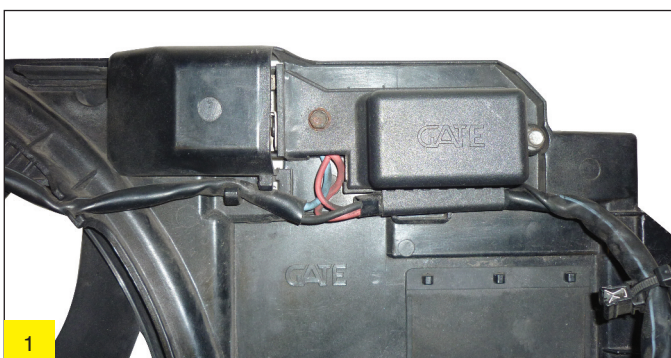
Using the supplied heat shrink butt connectors, connect the following wires together (Figure 4):

- The solid red wire of the new resistor to the larger of the two red wires of the original harness.
- The red wire with black stripe of the new resistor to the smaller of the two red wires of the original harness.
- The green wire of the new resistor to the blue wire of the original harness

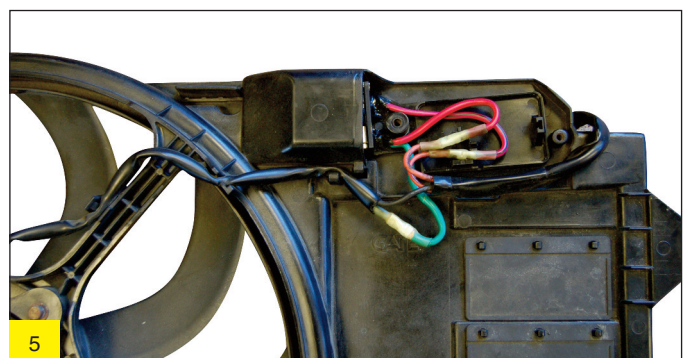
Once firmly crimped, apply heat to the connectors to activate the heat shrink and form a waterproof connection. (Figure 5)
