Technical Bulletin

Product Information: ADN189501 Halfshaft

Applications: Nissan Navara D40

Date Issued: 03/2012

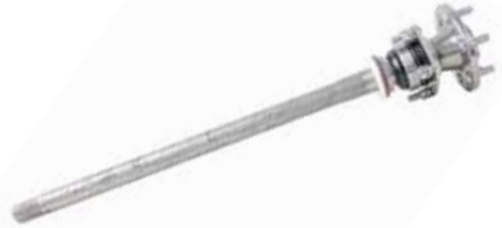
ADN189501

A complex setting up and alignment is required of all the components shim washers (choice of 8) to get the precise levels of end play. a complete halfshaft to OE specification which is fully assembled seal and new securing nuts with locking washers.

This means labour time is considerably reduced and there is far less Blue Print part is correct for all models fitted with a Limited Slip differential lock.
