Ford Focus Blower - High Speed Only

Getz - Just a Simple Nut to Remove

Do Not Touch the Bulb

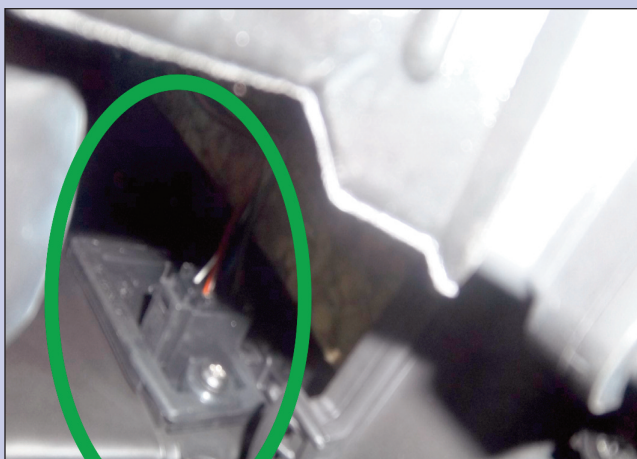
The heater fan on this Focus was only operating on one speed. The owner figured that one speed was good enough to carry out the task in hand. The single speed he had left was, of course, the fastest of the options and so demisting the screen was not a worry.

When the time came for the annual test and service, he asked us to sort the problem out, as long as it wasn't going to cost the earth. The faulty component was, as is often the case, in single speed fan operation, the heater rheostat.

The resistor pack is fitted into the heater housing just above the passenger footwell

Fitted up into the heater unit below the passenger foot-well, replacing the rheostat is

not too complex a job and the trickiest part is removing it from the housing once the retaining screw has been removed.

With the new resistor pack fitted, the Focus now had a range of fan speeds to suit all the driver's needs. No longer did he have to have the air blasting in for short bursts, he could now have a gentle constant flow.

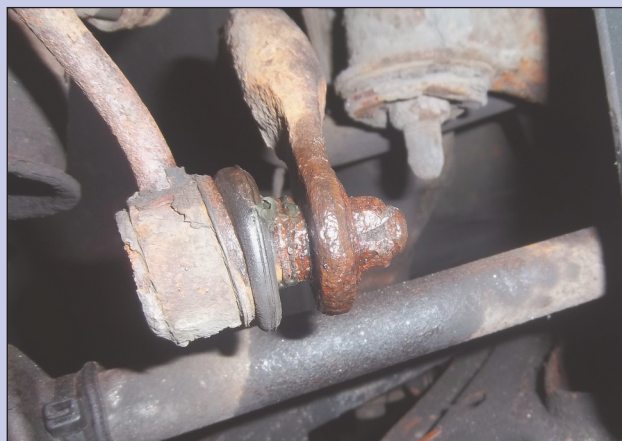
Arriving in our workshop because of a constant knocking noise, this 2004 Hyundai Getz required a new antiroll bar link arm. This is one of those jobs that in theory is very simple. Undo two nuts, remove the old arm and fit the new one into place.

The corroded nuts would not undo and needed to be cut off

This being the motor trade and the vehicle being a few years old, we knew it may not quite go to plan. As expected, both the securing nuts were badly corroded and neither had any intention of coming undone. The top nut is accessible as it faces outwards and this one can be easily cut off with an air saw.

The lower nut however faces inwards and even with the benefit of the air saw with a new blade fitted, this one was both difficult to access and difficult to cut through. Eventually, the old link arm was released and the new one fitted into place. The knocking noise was cured but as we had quoted for the repair before commencing the job, it wasn't a great profit maker.

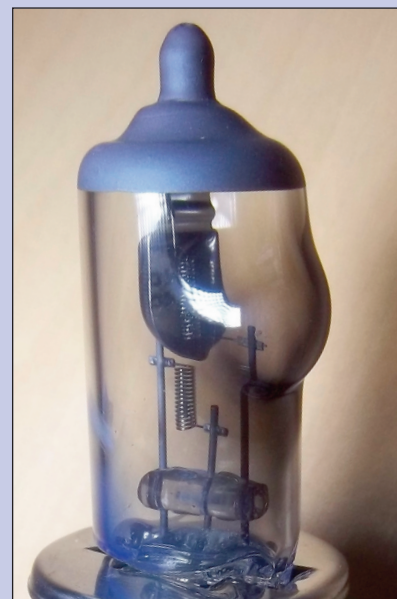
Acids in the skin had caused the glass to overheat and bulge out

He also asked us to check out the possible reason for the regular failure of the bulbs. With this in mind, we checked the connecting plug and earth connections along with the supply voltage before removing the headlamp bulb. When we did remove the bulb we had a fair idea of what had been the problem.

The bulb contained a large bulge in the side of the glass, this is normally the result of the bulb having been handled when fitted. The acids on the skin will react with the glass when heated to operating temperature and the temperature of the area will increase sufficiently to allow the glass to blow out of shape, allowing the gases in the bulb to escape. The filament then burns too hot and the bulb blows.

When returning the Honda to its owner we confirmed that this was the problem, and the owner now aware, would take greater care not to touch the glass of the bulb when it did next need replacing.
