Audi A4, '05 - Bumpy Feeling Brakes

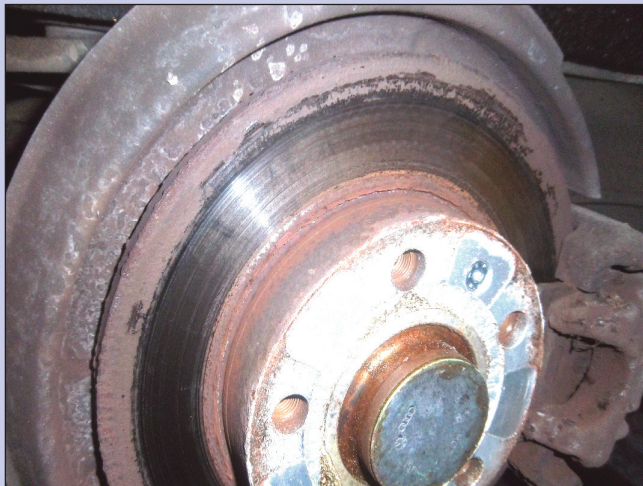
Rust had begun to eat into the surface of the

The corrosion around the disc face was causing the poor feel to the brake pedal

rear brake discs quite severely, and small sections were blowing out randomly around the surface of the disc. This was undoubtedly giving the bumpy feel to the brakes and our remedy was to fit new rear brake discs and pads. With the new components fitted, the Audi was given a quick road test. This confirmed that the problem was solved.

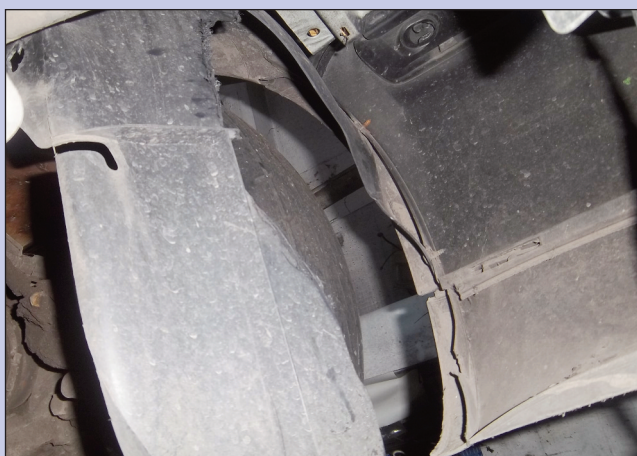
The inner wheel arch had been badly damaged after being dislodged

Looking from under the vehicle we discovered that the impact had resulted in the under shield being dislodged. This had pushed the inner wing out of shape, resulting in the inner wing contacting the road wheel on right turns.

The under shield was not badly damaged and we managed to fit it back into place, this resulted in the inner wing going back into shape, although a large piece of it was now missing

and would require replacing.

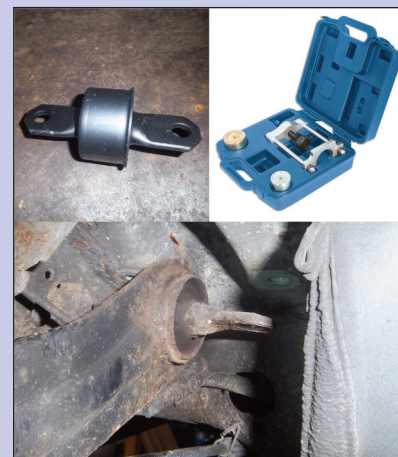
The rear trailing arm front bush is one of the regular test failure points we see on the Focus. Using the correct tool makes fitting a lot easier.

Some workshop tools are a luxury, others are almost indispensable. When we first replaced the front bush on the rear trailing arm of a Ford Focus, we did manage to complete the job without the aid of the special tool. The arm can be disconnected and lowered down below the floor of the vehicle giving a bit of working space.

Without the correct tool, the easiest way to remove the old bush is to cut through the rubber and the metal sleeve. This releases pressure and allows the bush to be tapped out. Fitting the new bush without the tool is difficult and requires a firm support of the trailing arm.

With the correct tool, the old bush can be pressed out and then the new one can be easily pushed into place by simply winding it in with the tool. This is one tool that definitely earns its keep in labour saving costs.

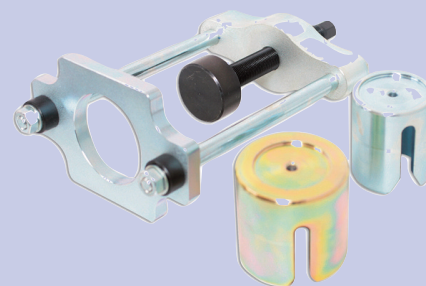
The tool is a Laser product, Laser Tool number 4437.
