BMW 330i - Locating the Belt Noise

Volvo V40 - More Than Just a Clutch

MINI - Locking Wheel Nut Key Storage

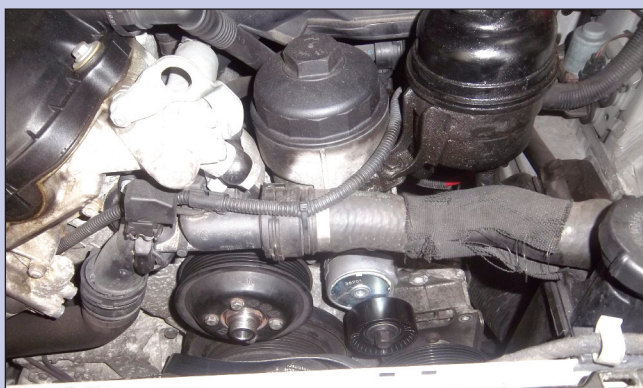
Having replaced the water pump and tensioner, we removed the alternator

Once these two components had been replaced, the belt was refitted and to our dismay the noise was still present. Our next step was to replace the alternator, although spinning freely by hand, this does not fully reflect the operating conditions of the unit, which when charging is under a far greater load.

Happily, when the alternator was replaced and the auxiliary belt refitted, the noise had been silenced.

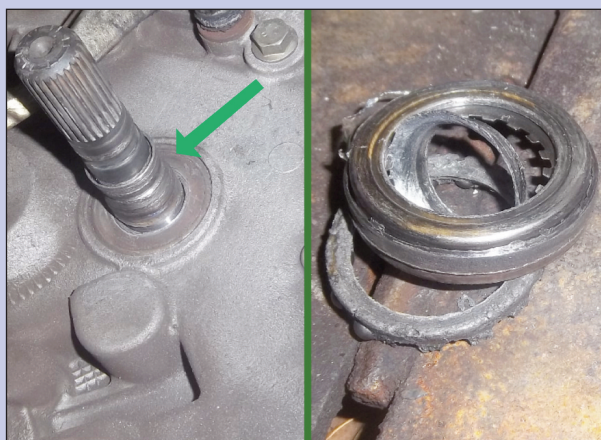
The clutch release bearing had broken up, and in so doing, had been dragged around the bearing carrier, wearing it away. On the later

The release bearing had broken to destruction and in doing so had taken out the guide tube

On this particular V40, the guide tube is part of the input bearing and disassembly of the gearbox is required to replace it. We now had to explain to the customer that the cost of the job was about to rise.

Softening the blow was the fact that we do have a great local gearbox centre who were able to carry out a repair quickly and cost effectively. Once this repair was completed, the gearbox was refitted and Volvo was back in top form.

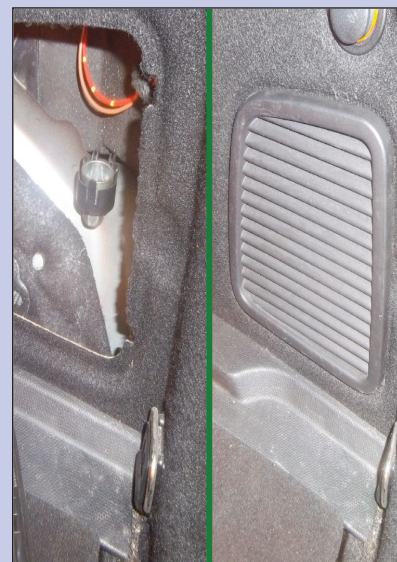
The locking wheelnut key is neatly tucked behind the small door, always ready and easily accessible

Opening the boot, the key is stored behind a small grill panel to the offside, sitting neatly behind the rear lamp unit.
