The Denso HP2 fuel pump

explained!

Written by Jim Gilmour - Blue Print Technical Consultant

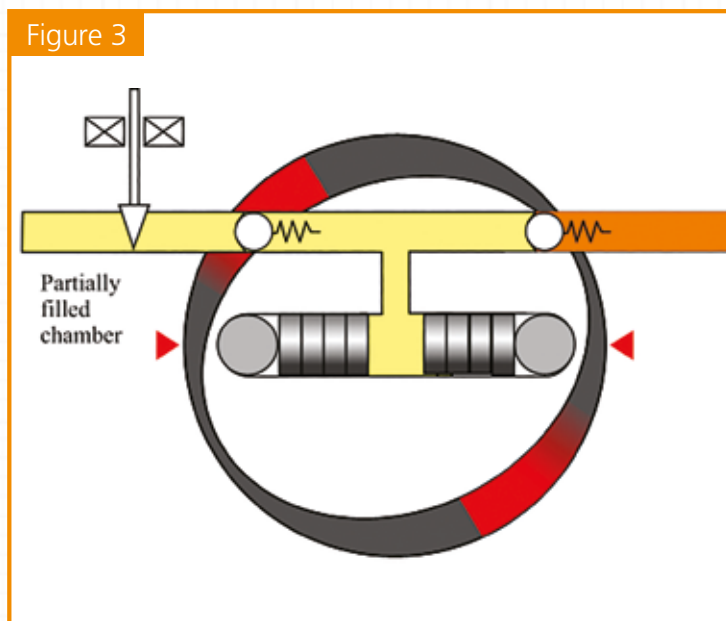
Figure 3 shows the single pumping chamber.

The amount of fuel delivered to the common rail is a function of the angle through which the rollers are in contact with the cam (*shaded red on Figure 3*). Both the contact angle and the common rail pressure are parameters on your scan tool; the relationship between engine speed, contact angle, injection quantity and common rail pressure are monitored for plausibility.

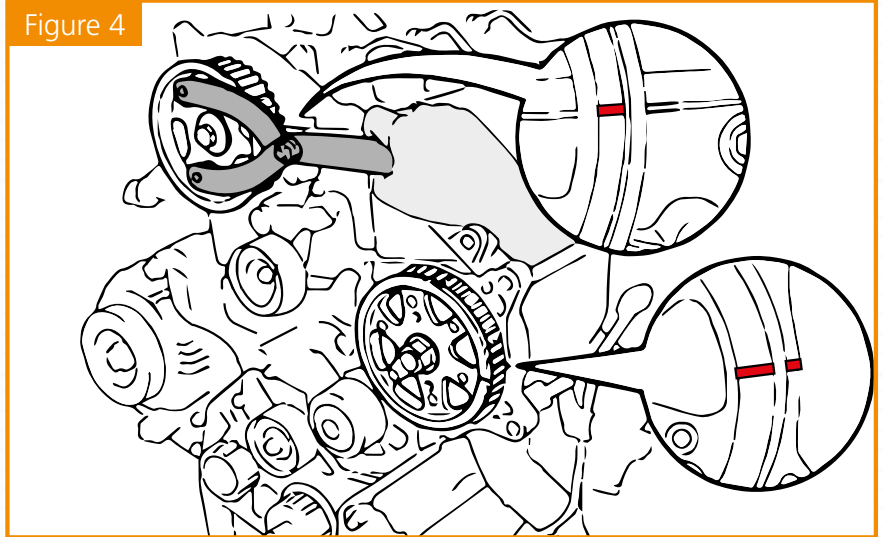
Figure 4

As a result of this method of control, the opening of the SCV has to be timed to allow the flow of fuel into the chamber when the internal cam is at its maximum stroke. This means that the pump drive pulley has to be timed to the engine. This must be kept in mind when replacing the cam belt (*Figure 4*).

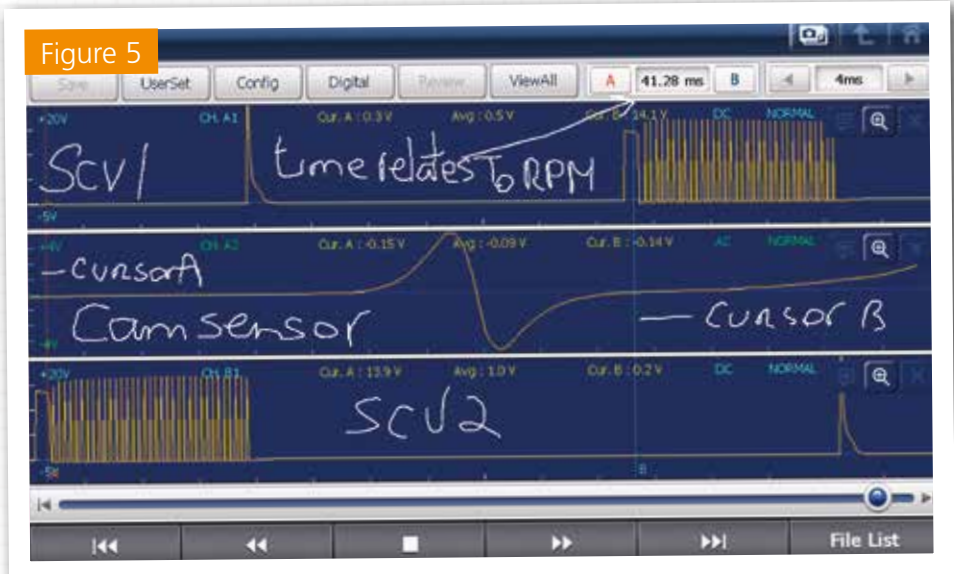
Figure 5 shows an image from the G-Scan 2. The scope is set up to show 3 of the 4 possible channels. Channels A1 and B1 are connected to the PCV 1 and 2 terminals and a common ground. Cursors A and B are set to the start of the SCV "on" time. The scope pattern shows the individual switching of the two SCVs 180° of engine rotation apart. The rapid switching effect is used to limit the current through the SCV winding and prevents overheating. The clean scope pattern shows that the feeds and earths are intact. It is still a good idea to check that the resistance of the field winding meet manufacturer's specification.

Figure 5 shows the scope image on Blue Print's G-Scan 2.
