Technical Bulletin

Toyota Avensis Dual Mass Flywheel Information – ADT33505C/ADT330206

Date Issued: 16/3/2009

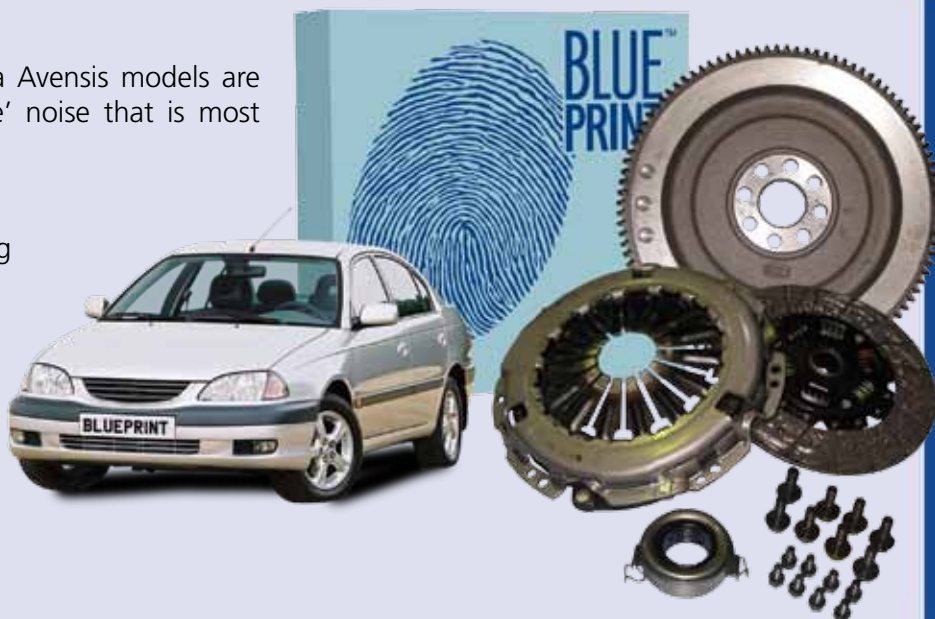
It has been identified that certain Toyota Avensis models are prone to developing an abnormal 'rattle' noise that is most audible under the following conditions.

1. Engine Idling
2. During clutch engagement when pulling away approx 1,000rpm
3. When shifting from 1st to 2nd gear

Certain Toyota Avensis models are fitted with a two piece Dual Mass flywheel that contains a cushion rubber which, during extended periods of engine idling, results in excessive heat and stress on the dual mass flywheel. Under these circumstances the cushion rubber can become detached on the acceleration side and hardened/cracked at the deceleration side, which then results in noise and possible failure of the dual mass flywheel. This may contribute to premature clutch failure.

If the vehicle has a dual mass flywheel that has failed, this should be replaced with a Blue Print dual mass flywheel (Part number **ADT33505C**) which matches the modified design currently supplied by Toyota Europe.

Alternatively, if the vehicle is being used as a taxi or spends a lot of time travelling short journeys, Blue Print's modified clutch kit ADT330206 (which includes a single mass flywheel and all the fittings) should be installed. This is because excessive stress and vibration is placed on the dual mass flywheel during prolonged periods of engine idle which can drastically reduce its service life.

Please note – If a single mass flywheel is fitted then there may be a slight increase in the levels of vibration at idle compared to the dual mass type.
