# Toyota Aygo clutch replacement

The Toyota Aygo (KGB10), which is platform shared with the Citroën C1 and Peugeot 107, is known to suffer from premature clutch disc wear. Some drivers also complain about clutch noise. Blue Print gives some advice on how to successfully replace this clutch

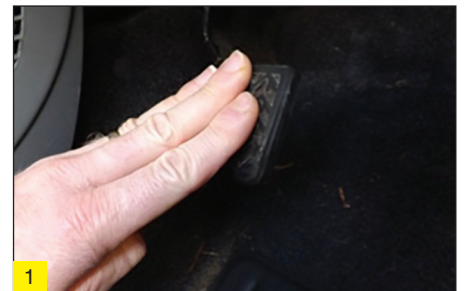
1. Push the clutch pedal down by hand (Fig. 1) checking for smoothness of operation. Stiffness or roughness in operation will require further investigation to determine the root cause.
2. Measuring the free play in the pedal can be done quickly and easily, by applying

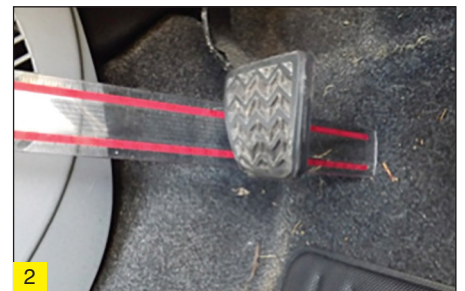
(approx 15-20Nm) until you feel the amount of pressure required increase. Measure the distance travelled by the pedal with a ruler. The amount of free play in the clutch pedal should be 23mm, +/- 5mm (Fig. 2).

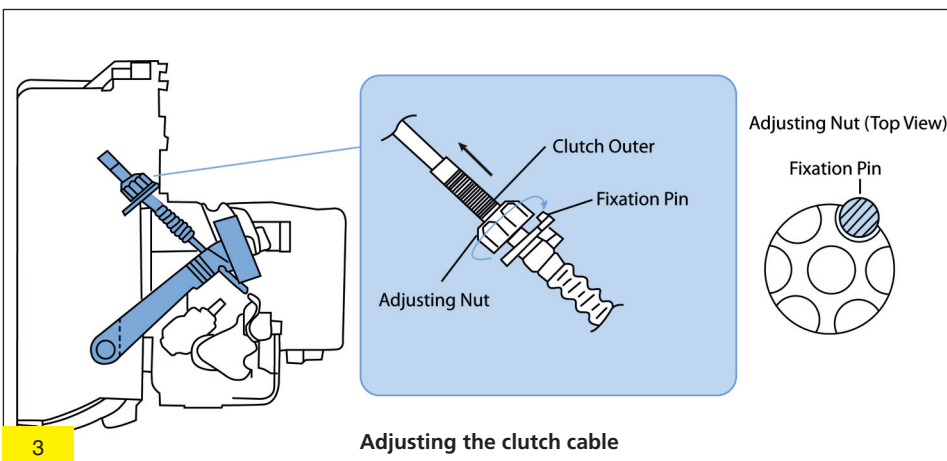
1. Pull the clutch outer cable until it is released from the Fixation Pin (approx 3mm).
2. Rotate the Adjusting Nut to increase or decrease the free play as necessary (1 full turn of the Adjusting Nut is equivalent to about 6.5mm of pedal free play).
3. Ensure the Adjusting Nut is locked back in place on the fixation pin after adjustment.
4. Operate the clutch 2-3 times.
5. Re-measure the clutch pedal free play and adjust as necessary.

After adjustment, the clutch pedal may be higher than the brake pedal. A higher clutch pedal is normal, but be certain to explain this to your customer.
