Technical Bulletin

Toyota Celica 2.0 GT Injection (ST182/3S-GE) CV Joints

Date Issued: 01/07/02

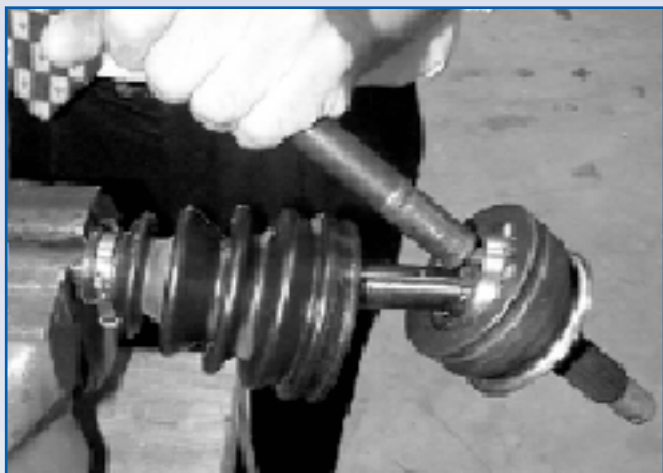
Removal of the original joint

Difficulty is often encountered removing the original CV joint from the driveshaft on the above application. This is because the manufacturer uses a 'heavy duty' type internal circlip to retain the joint. It is sometimes necessary to cut or grind the original joint from the shaft, taking great care not to damage the shaft splines. If a disc grinder is used, the grease must be cleaned out to prevent the likelihood of fire.

Below is a guide to the removal of the original joint.

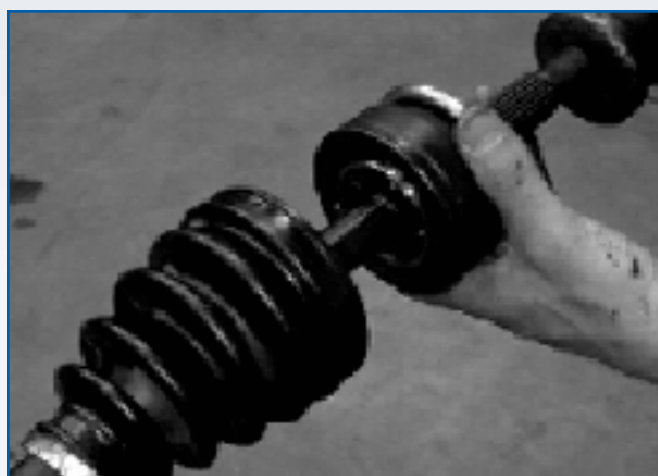
Installation of new joint
