Clutch component failure diagnosis part 3

Despite the complex nature of the modern clutch system, many technicians remain under the misapprehension that clutch replacement is a simple and straightforward affair. However, with clutch replacement now often taking several hours, it's imperative to workshop profitability, that technicians have the information they need to fit the replacement right, first time. Borg & Beck highlights some common failures and their causes.

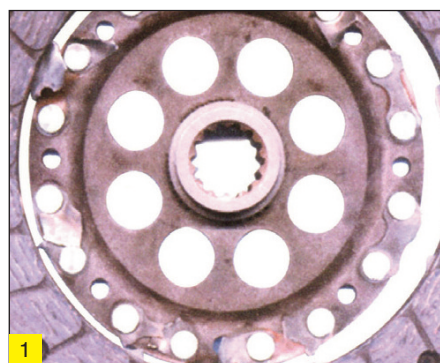
Broken Segment Necks (1)

Angular misalignment of engine and gearbox.

Loss of drive.

Correct the misalignment which may be due to bent engine back plate, burrs or debris trapped between mating faces, cracked bell housing; worn pilot or gear box bearings; incorrect or missing dowels.

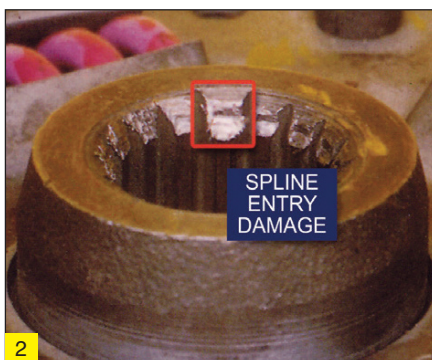
Damaged Spline (2)

Failure to correctly align spline with driven plate during gearbox installation.

Clutch drag.

Replace driven plate and take care during gearbox installation.

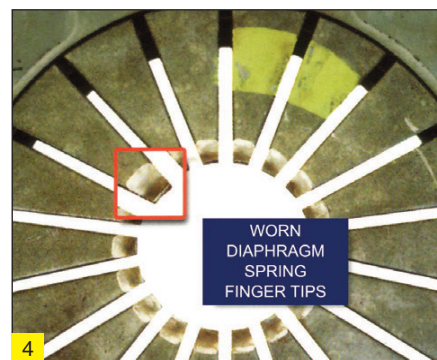
Worn Diaphragm Spring Fingers (4)

Failure to maintain a contact between bearing and clutch assembly.

Jerky clutch engagement.

Renew cover assembly, check release mechanism (including self adjustment) for correct operation. Observe correct adjustment frequency and procedure.

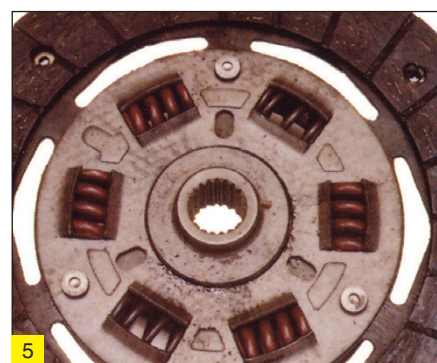
Oil Contaminated Driven Plate (5)

Oil leak from gearbox main shaft seal or from engine main bearing seal.

Progressing through clutch drag, judder and finally slip.

Eliminate oil leak and renew clutch components.
