# Clutch component failure diagnosis part 4

To help mechanics, clutch specialists Borg & Beck have produced a useful fault diagnosis chart to highlight the issues that can result from incorrect clutch fitment, so that fitting problems can be avoided and business profits and customer satisfaction retained. Using the chart to recognise the symptoms, technicians can identify the cause, its effect and the remedy and therefore prevent costly installation problems before they occur. The examples below are just a portion of those on the chart.

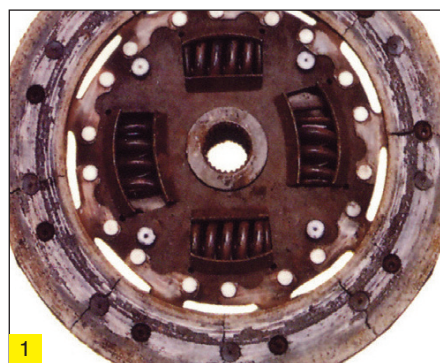
## Overheated, Cracked Facings (1)

Prolonged slipping of the clutch.

Clutch drag followed by loss of drive.

Rectify cause of clutch slip and then replace all necessary clutch components. Check flywheel for damage.

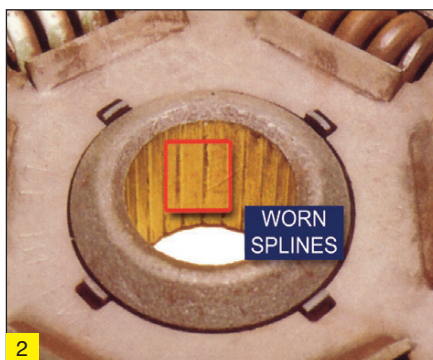
## Worn Away Hub Splines (2)

Bent first motion shaft or worn gearbox bearings.

Loss of drive.

Correct the gearbox fault and replace the driven plate.

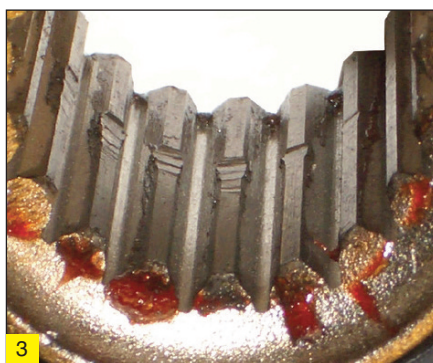
## Hung gearbox (3)

Gearbox has not been fully installed and left unsupported.

Clutch drag due to the damage within the spline.

Replace clutch kit and use a cradle to support the gearbox.

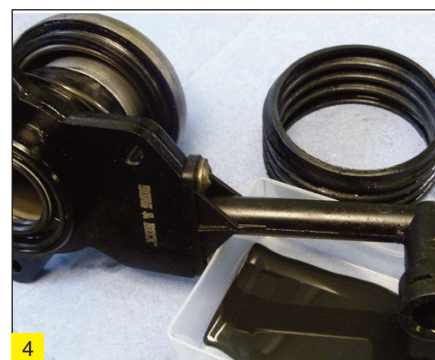
## Contaminated Oil in Gearbox (4)

Clutch fluid has not been maintained & become contaminated.

Fluid leakage due to internal seal expansion.

Replace CSC & check clutch for contamination. Flush & replace clutch fluid.

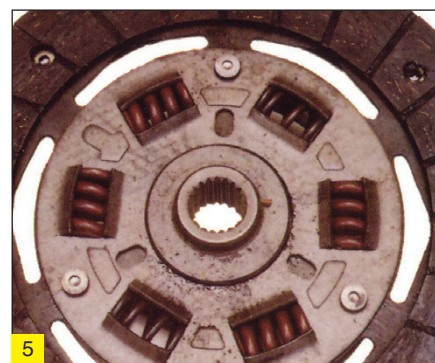
## Oil Contaminated Driven Plate (5)

Oil leak from gearbox main shaft seal or from engine main bearing seal.

Progressing through clutch drag, judder and finally slip.

Eliminate oil leak and renew clutch components.
