VAG brake light switch fault

The switches for the VAG Group brake lights are very delicate and much care should be taken when replacing them. In this specific case, we are going to talk about repeated incidents relating to the brake light switch and in passing, we will explain how to adjust and replace them.

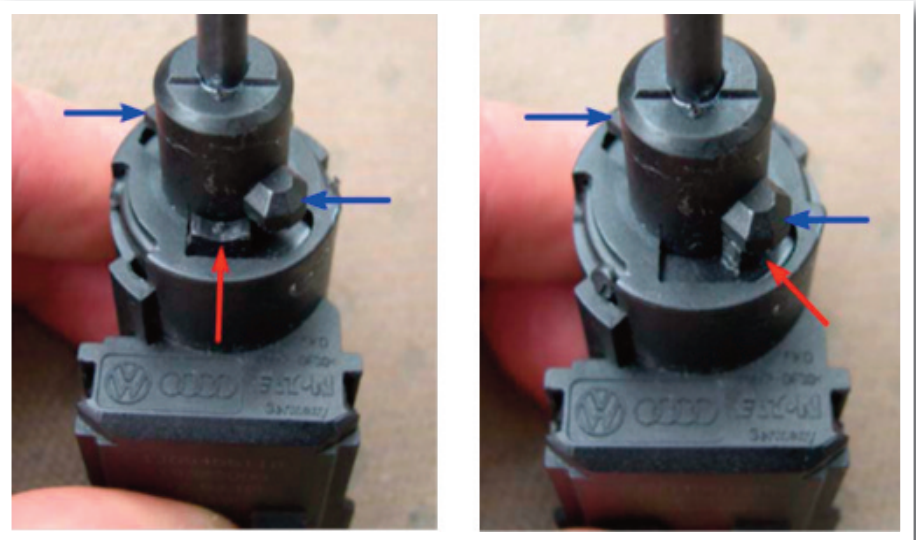
Fig. 1 Locking tabs on the brake pedal switch

There are three tabs in the internal mechanism, and once the switch is inserted into the hole in the support and is rotated in its position, the third tab (red arrow in fig 1) remains fixed and allows the external cover to rotate.

Remember that when the switch is rotated, it is secured to its support and the position of the internal mechanism also rotates, locking the length of the plunger.

If the switch is rotated before it is fixed in the stop and the third tab is not engaged, the internal mechanism will break. For this reason, it must be confirmed that the switch has been inserted on the stop to ensure that the plunger is compressed against its spring.
