VAG brake light switch fault

The switches for the VAG Group brake lights are very delicate and much care should be taken when replacing them. In this specific case, we are going to talk about repeated incidents relating to the brake light switch and in passing, we will explain how to adjust and replace them.

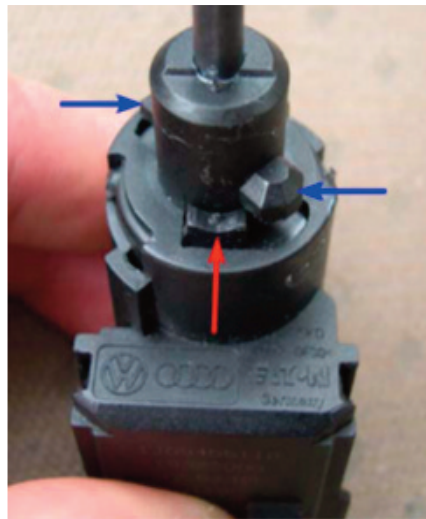
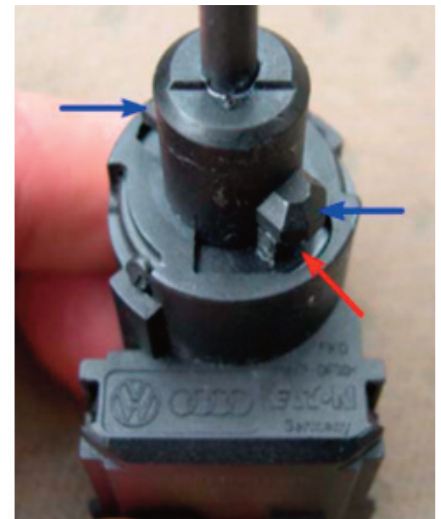
Fig. 1 Locking tabs on the brake pedal switch

There are three tabs in the internal mechanism, and once the switch is inserted into the hole in the support and is rotated in its position, the third tab (red arrow in fig 1) remains fixed and allows the external cover to rotate.

Remember that when the switch is rotated, it is secured to its support and the position of the internal mechanism also rotates, locking the length of the plunger.

If the switch is rotated before it is fixed in the stop and the third tab is not engaged, the internal mechanism will break. For this reason, it must be confirmed that the switch has been inserted on the stop to ensure that the plunger is compressed against its spring.

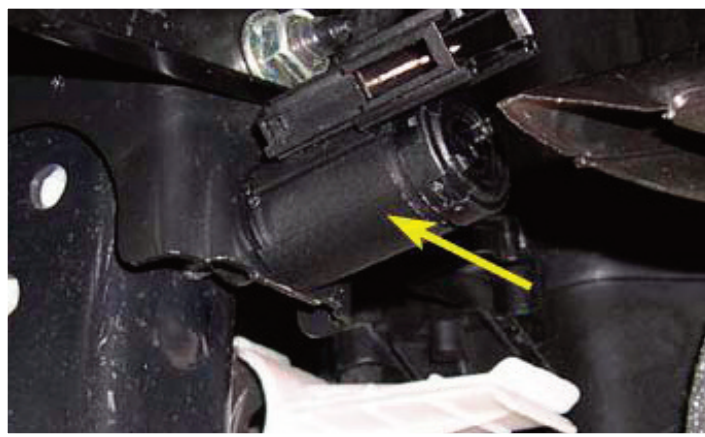
Fig. 2 The brake pedal switch installed on the pedal assembly

NOTE: Check that the switch is released before installing it. It will be about 25 mm long in the released position. To release it, press the plunger inwards and rotate the outer housing. To install the new switch, press the brake pedal to the bottom stop.
