Malcolm Short, Schaeffler

Front wheel bearing

Avensis D4D

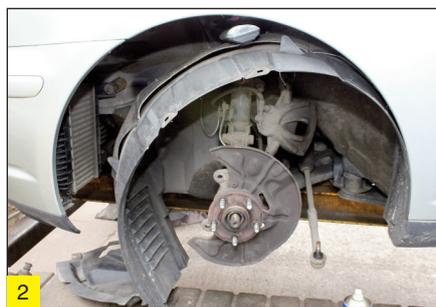
Remove the brake calliper and support it by hooking it directly to the coil spring (fig 1). Remove the two bolts that secure the brake calliper mount to the hub and remove the complete assembly away from the work area. You will need to gain access to the wheel arch, but the removal of the wheel arch liner is unnecessary, just remove the fixing bolts to the front half of the liner and allow it to hang down (fig 2). The ABS sensor is to be disconnected and this is found inside the wheel arch. With the liner now free, you will have enough access
