# Replacing front bearings on a Opel Meriva 1.4

The Opel Meriva is a popular, compact MPV. The generation 1 went on sale in May 2003 and continued until 2010, when the Meriva generation 2 was launched. In this article we are replacing the left front wheel bearing on a generation 1 Meriva, so we can give some handy hints and tips to aid independent garages with such repairs. With a book time of 1.1 hours, anything to help save time is an advantage.

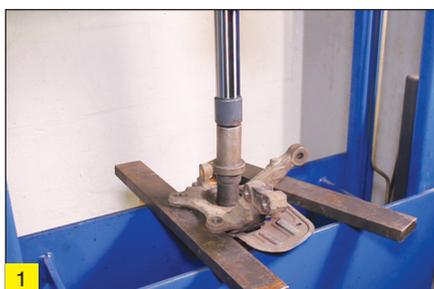
You are now in a position to remove the bearing. Firstly, we need to press out the drive flange, so support the body of the hub assembly on the press, giving clearance for the drive flange to be pressed out, and now use a correct size mandrel to press on the drive flange ensuring it will pass through the inner race of the bearing (figure 1) and press the flange out of the bearing.

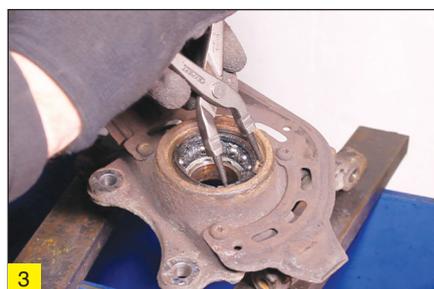
Now remove the internal circlip from the hub assembly using the correct size circlip pliers (figure 2), and the bearing can be pressed out. Support the hub assembly, ensuring clearance for the bearing to be pressed out, using the inner race to press on, press out the bearing. Once the bearing has

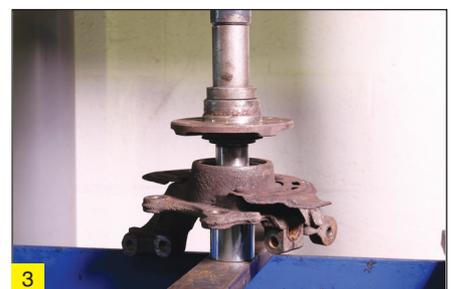
Ensure the circlip groove is clean, using a wire brush if required, and place the hub assembly on the press. Press the new bearing on the outer race, not on the inner race, this will ensure that the pressing force is not being transmitted through the balls or rollers in the bearing, but only through the outer race. Press the bearing up to the shoulder and now the new circlip can be installed, then support the underside of the bearing inner race and press the flange into the new bearing (figure 3).
