Replacing front bearings on a Opel Meriva 1.4

The Opel Meriva is a popular, compact MPV. The generation 1 went on sale in May 2003 and continued until 2010, when the Meriva generation 2 was launched. In this article we are replacing the left front wheel bearing on a generation 1 Meriva, so we can give some handy hints and tips to aid independent garages with such repairs. With a book time of 1.1 hours, anything to help save time is an advantage.

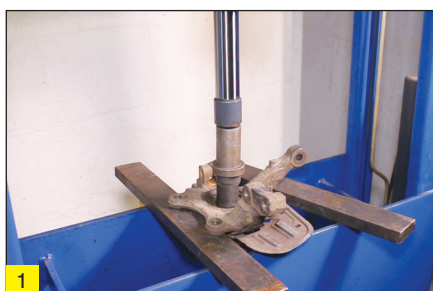
You are now in a position to remove the bearing. Firstly, we need to press out the drive flange, so support the body of the hub assembly on the press, giving clearance for the drive flange to be pressed out, and now use a correct size mandrel to press on the drive flange ensuring it will pass through the inner race of the bearing (figure 1) and press the flange out of the bearing.

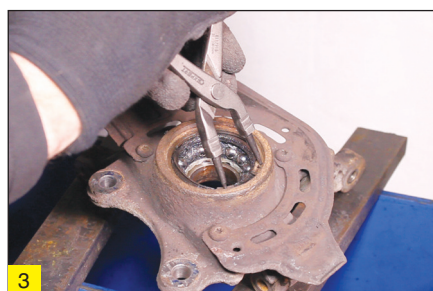
Now remove the internal circlip from the hub assembly using the correct size circlip pliers (figure 2), and the bearing can be pressed out. Support the hub assembly, ensuring clearance for the bearing to be pressed out, using the inner race to press on, press out the bearing. Once the bearing has

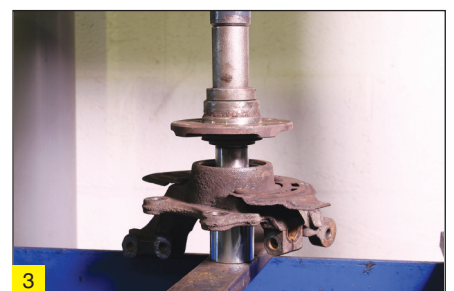
Ensure the circlip groove is clean, using a wire brush if required, and place the hub assembly on the press. Press the new bearing on the outer race, not on the inner race, this will ensure that the pressing force is not being transmitted through the balls or rollers in the bearing, but only through the outer race. Press the bearing up to the shoulder and now the new circlip can be installed, then support the underside of the bearing inner race and press the flange into the new bearing (figure 3).
