Technical Bulletin

Torsional Vibration Dampers

GATES REFERENCE :	Various
MAKE :	Various
MODEL :	Various
ENGINE :	Various
ENGINE CODE :	Various

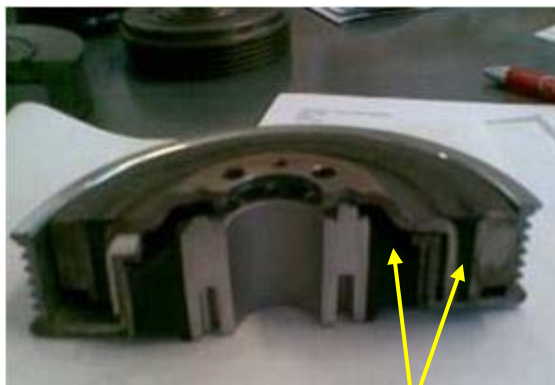
Fig. 1

So it is important to dampen these excessive vibrations. One way to do this is by the dual mass flywheel which can be found on the majority of modern engines, but it is also done by the Torsional Vibration Damper (TVD). These TVD pulleys are crankshaft pulleys with a rubber element between the 2 main metal parts (Fig. 1).

Rubber element

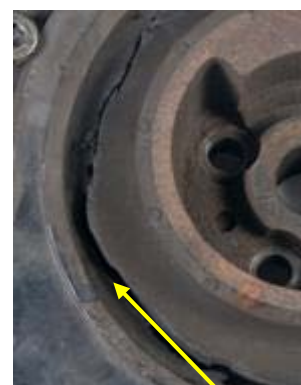
Fig. 2

Cracked rubber

This connecting rubber functions as the damping element. Because of its material (rubber) and its purpose (damping vibrations), it wears out and will need replacement after a certain time (Fig. 2).

- 1) Cracks in the rubber (Fig. 2)
- 2) Parts of rubber missing (Fig. 5).
- 3) Clear contact marks from metal "indicator" in slotted holes (Fig. 6)
- 4) Some TVD's will show rust particles on the outside as an early warning
- 5) A Micro-V[®] belt running out of the pulley (Fig. 7) could be the result of a faulty TVD
- 6) Draw/paint a line over the TVD (from outside to center), run the engine for a minute (while hitting the gas a few times), switch the engine off and check if the line is broken. If so, the TVD needs replacing!

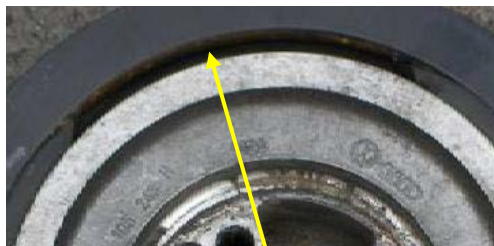
Fig. 5

Missing rubber

- The TVD should be replaced when the ABDS belt and tensioner are replaced. We recommend to change it no matter what after 120.000KM
- At each service, especially after a car crash, the TVD has to be carefully checked for signs of wear or damage. At least every 60.000 KM! In most cases wear/damage is visible on the backside of the pulley sooner than on the front side.
- The wear will not always show, but TVD or belt noise is proof of a problem.
- In order to guarantee the optimum performance of the TVD, it should be installed according to the manufacturer's recommendations.
- Many TVD's are bolted on the engine with stretch / elastic bolt(s), which need to be replaced after removal, **fitted to the correct torque!!!**

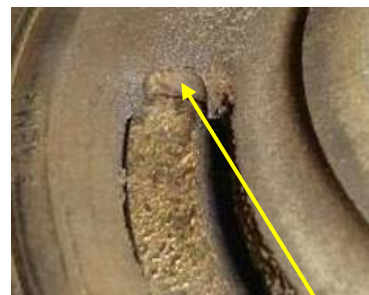
Fig. 6

Damaged slotted hole
