BULLETIN

Audi A1 (8X) Model year: from 2010 onwards Engine: 1.6 TDI

Exhaust gas recirculation radiator Engine warning light comes on

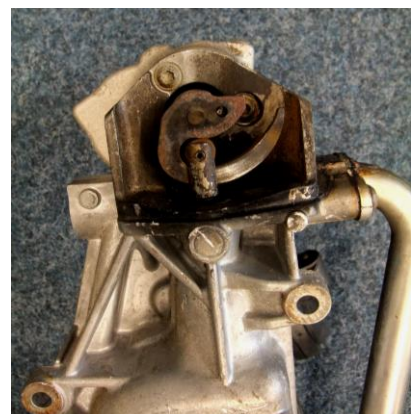
Figure 2

Furthermore, the mechanics of the actuator motor (Figure 2) and the vacuum cell must be checked to ensure that they run smoothly. They may often jam or fail to run smoothly, leading to faults.
