Audi A3 (8P)

Lack of cooling performance and noises from the engine compartment

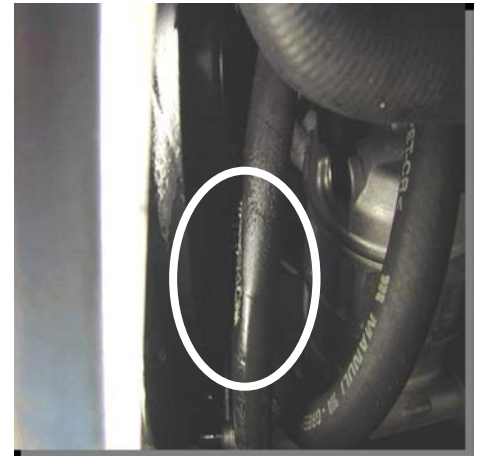
Fig. 1

If there are complaints about the above-mentioned faults, the cause could be a worn refrigerant hose (Fig. 1). Due to an incorrect angle of the refrigerant hose from the compressor to the condenser (high pressure line), the hose can come into contact with the radiator fan.

In this case the hose and fittings have to be replaced. The new hose must then be fixed in place using a closed clip (Fig. 2) or a cable tie, in such a way that contact with the radiator fan is no longer possible. From chassis number 8P4A017591 onwards improved refrigerant hoses with modified angles have been used.
