Audi TT With 1.8 l engine and xenon light

Replacing the front indicator bulbs.

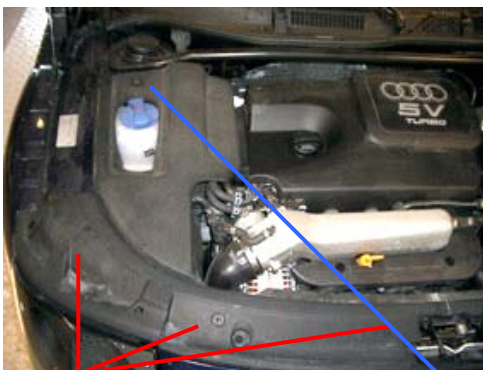
Clip (a) Screw (b)
Fig. 1

- Remove the plastic trim in the engine compartment by loosening the 3 clips (a) and the screw (b) (Fig. 1).
- The indicator socket is underneath the xenon ballast (Fig. 2).
- The indicator socket is loosened by being turned anti-clockwise.

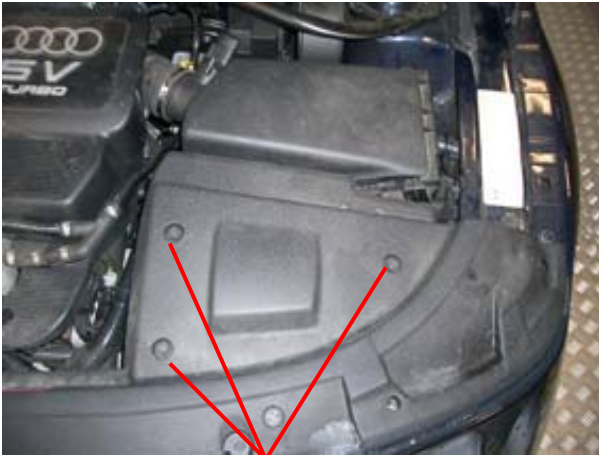
3 screws
Fig. 3

- Remove the trim covering the battery by loosening the 3 screws (a) (Fig. 3).
- The indicator socket is directly beneath the xenon ballast (Fig. 4) and is also loosened by being turned anti-clockwise.
- To make access to the indicator socket easier, the air filter box should be removed completely (Fig. 5).

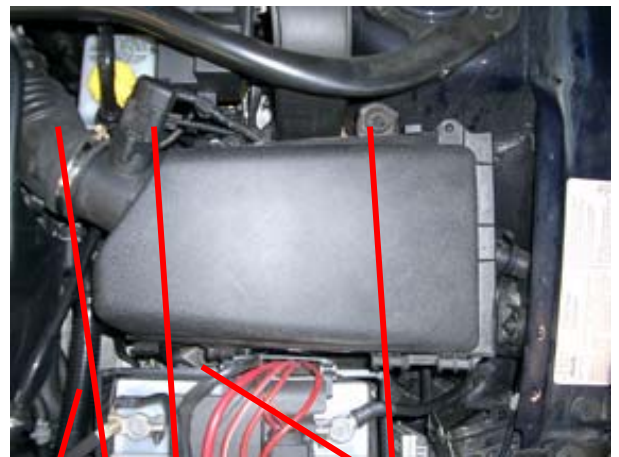
Fig. 6

- To do this, loosen the two screws (a), the suction pipe (b), the plug on the mass air flow meter (c) and the plastic hose (d) and lift out the air filter box completely (Fig. 6).
