Audi / VW

All diesel engines

Model year: 1998–2004

Coolant loss at the glow plugs

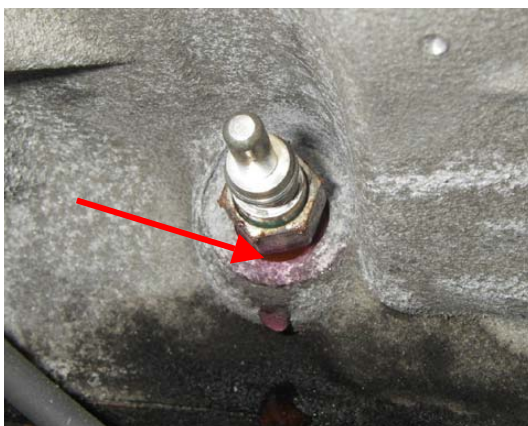
In the case of the above-mentioned vehicles, coolant may escape via the thread for the glow plug (see photo). This can be caused by unfavourable production tolerances. In case of complaint, proceed as follows:

- Unscrew the glow plugs and check
- Remove coolant residues from the glow plugs and the thread in the cylinder head
- Clean the thread of the glow plugs and the cylinder head (wire brush).
- Apply a suitable sealing agent (available from the vehicle manufacturer) to the thread of the glow plugs
- Fit the glow plugs and tighten to the specified torque
