# BULLETIN

## BMW 1 series (F20) Model year: 2010 - 2015 Engine: N13 B16A

### Loss of coolant/coolant sensor

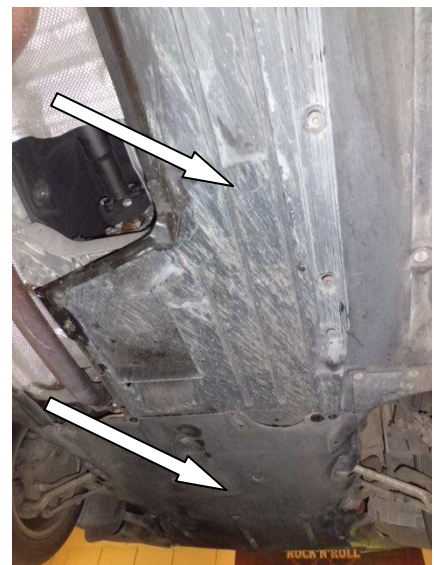
Figure 1

- Remove the floor paneling (engine/transmission; Figure 1)

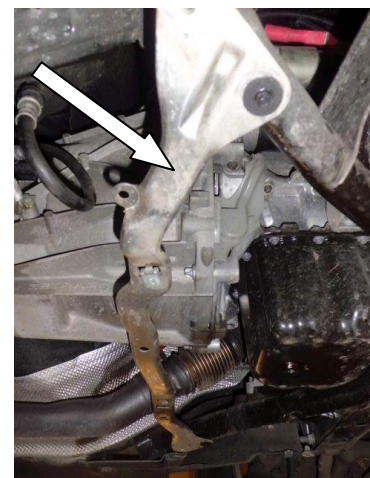
Figure 2

- Remove the cross-strut (Figure 2)

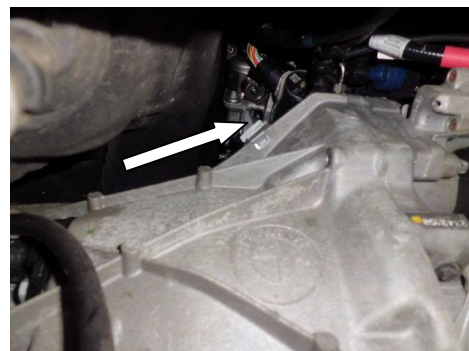
Figure 3

- The coolant sensor is on the right, above the clutch bell (Figure 3)

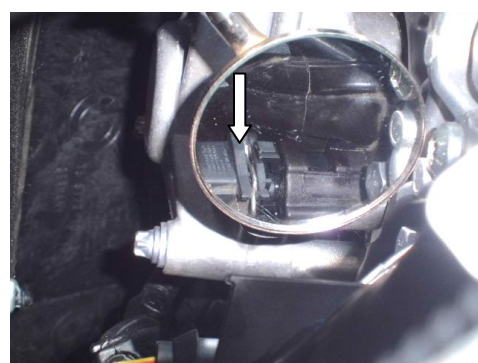
Figure 4

- Use a mirror to check the position of the sensor/connector
  - Unlock and disconnect the connector (Figure 4)
  - Unlock the sensor (push the two locking tabs together) and pull it out
- Caution: Coolant will escape when you do this.

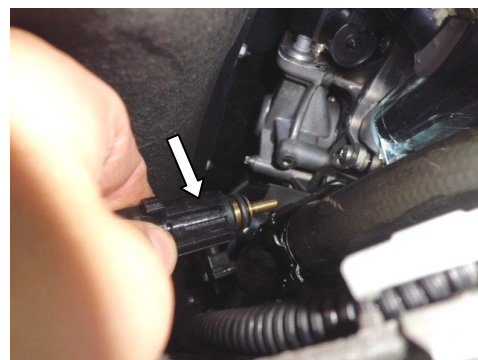
Figure 5

- Coolant leaks out through a crack in the coolant temperature sensor housing (Figure 5)
