BMW 5 Series (E39) - all models with automatic transmission

Vehicle does not start when selector lever is in P or N position.

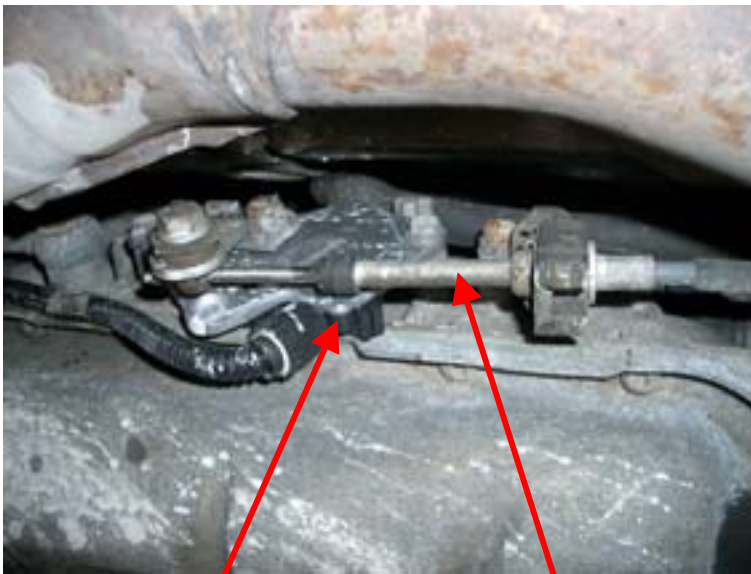
If there are complaints about the above-mentioned fault, one possible cause is a defective selector lever position switch.

Selector lever position switch

Gear change cable

- Check the fault memory read-out for the gearbox control unit (if possible).
- Check the gear change cable adjustment.

If the gear change cable adjustment is alright, the selector lever position switch should be replaced.
