BMW E30, E36, E34, E39 Radiator leaking

New radiator leaking after installation

Bulletin

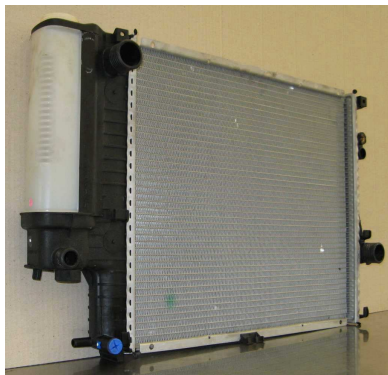
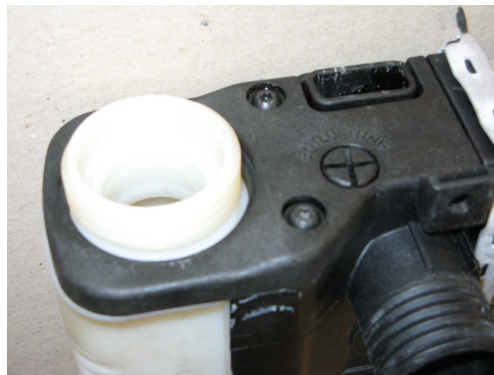
Since the expansion tank is installed in the radiator as a separate component, there is a recess behind it where part of the liquid can collect. This can drain off through an opening on the base of the tank.

After the area has been blown out using compressed air, the rest
of the liquid evaporates as the engine gets warm.

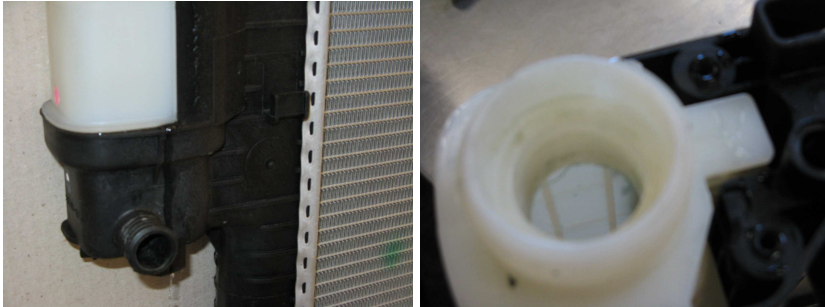
At a quick glance, it may look like
the radiator is leaking and liquid is escaping from the radiator.
