BMW E 34/36, Hissing noises

Intermittent hissing noises from the glove box area.

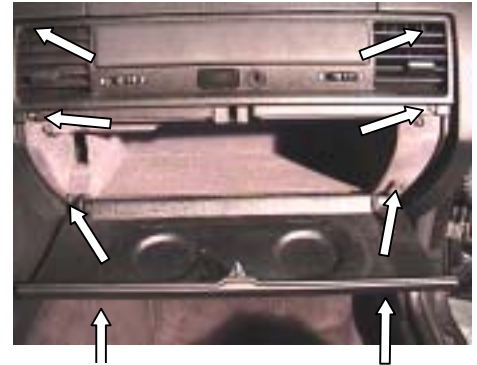
Fig. 1

Take off the screw cover and remove the screw's (Fig. 1)

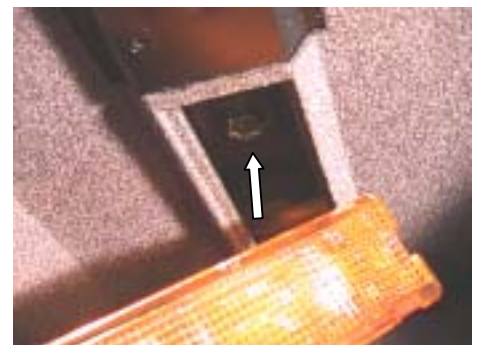
Fig. 2

Remove the screw (illumination glove box) and take out the glove box (Fig. 2)

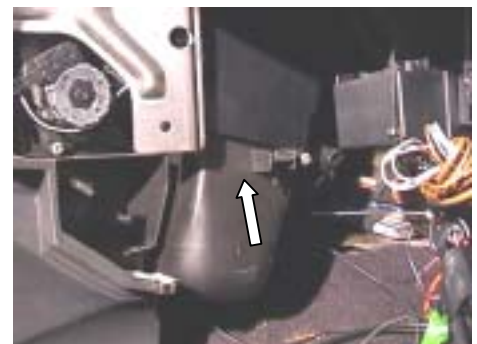
Fig. 3

Open the right side of the case and expose the expansion valve (Fig. 3)

Cover the expansion valve as thickly and completely as possible with the plasticine. This repair should muffle the hissing noises
