BMW E39 Touring (estate)

Faulty function of the rear windscreen wiper

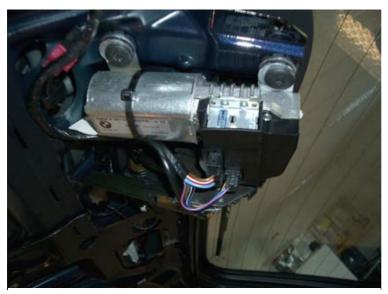
The reason for this fault can be a faulty rear windscreen wiper module. This is situated on the rear windscreen wiper motor (photo). To eliminate the fault, a new rear windscreen wiper motor must be installed.

Rear windscreen wiper motor with module
