Coolant pumps

General

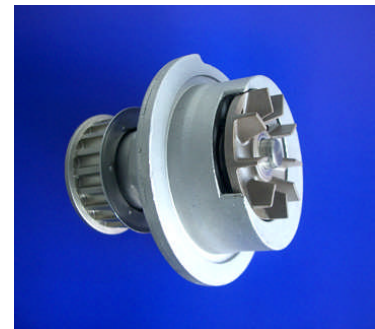
Figure 1

Coolant pumps (Figure 1) are mostly driven mechanically, by a toothed belt or V-ribbed belt, and transport the coolant through the engine's coolant circuit. The pumps can be flanged directly to the engine or also installed away from it. The designs are quite different. Coolant pumps must withstand huge variations in temperature (-40 °C to approx. +120 °C). Changing speeds (500 - 8000 rpm) and pressures of up to 3 bar require high stability of bearings and seals. To save fuel, electrically driven and electronically controlled pumps will increasingly be used in the future.

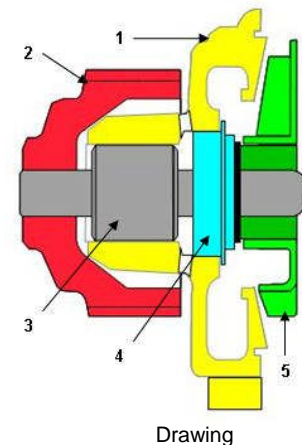
Drawing

A mechanical coolant pump consists of the following 5 sub-assemblies (drawing):

1. Body
2. Drive gear
3. Antifriction bearing
4. Mechanical seal
5. Vane

The drive gear and the vane sit on a common shaft. A mechanical seal seals off the pump shaft towards the outside. The rotation of the vane transports the coolant through the cooling system. Vanes are usually made of plastic or metal. The bearing load is lower with plastic vanes. At the same time, they are not as susceptible to cavitation. However, plastic vanes sometimes become brittle with age. The mechanical seal (Figure 2) is always lubricated and cooled by the coolant. Due to the design, minimal amounts of coolant can enter the space behind the seal and exit at the relief hole of the pump. Traces of coolant that may be

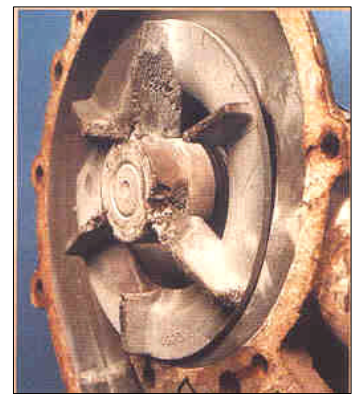
Figure 3

- Mechanical damage:
 - Loose/broken vane
 - Bearing or seal broken
 - Drive gear damaged
- Cross-section constricted by corrosion or sealant
- Cavitation:
 - Damage to the vane by the forming and collapsing of vapour bubbles in the coolant (Figure 3)
- Electrical fault (short-circuit/interruption)

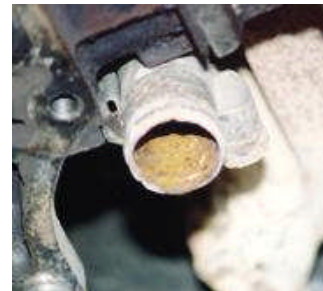
Figure 6

Corrosion in the entire cooling system (Figure 6):

- Defective cylinder head gasket - engine exhaust gases enter the cooling system. Negative variation of pH

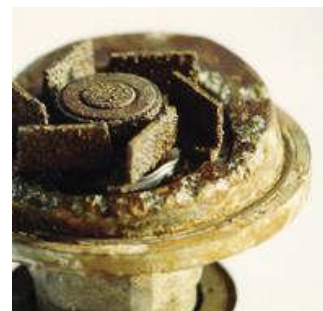
Figure 7

Pump parts such as vane, body, mechanical seal and shaft severely damaged by hole corrosion (Figure 7):

- Old/stale coolant with high content of chlorides (salt compounds) in conjunction with elevated temperatures.

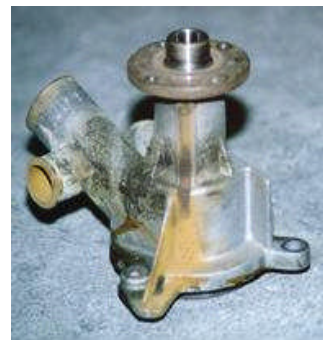
Figure 8

Excessive leakage of coolant from the relief hole (Figure 8):

- Caused by corrosion in the cooling system
