Technical Information

Electrical exhaust gas recirculation valve Failure causes and troubleshooting

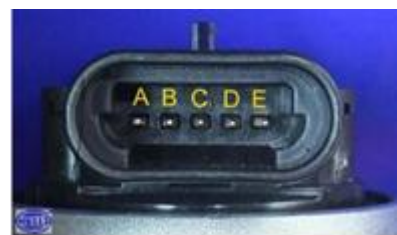
Electrical test

The resistance between the contact pins in the valve connector is measured at room temperature using a multimeter. Please always observe the information provided by the vehicle manufacturer when performing these tests.

Measurement:

1. connectors A and E = resistance 5.25 - 5.85 Ω
2. connectors B and D = resistance 2.10 – 4.90 k Ω
3. connectors B and C = resistance > 500 Ω

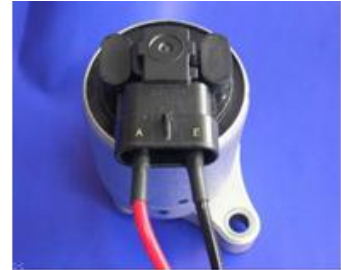
Solenoid voltage test

Solenoid to a fused voltage supply, battery or power supply, connect with 12.0 to 13.5 volts.
Contact pin E to battery plus.
Cycle contact pin A to ground (max. 5x for 0.5 secs).
The valve must audibly operate and should open and fully close without disturbance.

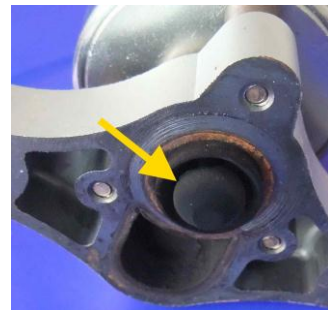
Comparison with a new EGR valve

Although the electrical tests reveal no defects, it was clear to see that the valve is defective during the mechanical test. The valve pintle jams when open and cannot be moved by the tensile force of the solenoid. Combustion residue deposits are the cause. As the vehicle grows older or in the event of a mechanical engine fault, the ingress of engine oil into the combustion chamber may intensify this contamination, potentially resulting in blockage of the valve (arrow). In this case, the cause should be remedied prior to replacing the EGR valve to prevent a further failure after a brief period.

As can clearly be seen in the image, the contaminated EGR valve (1) is already open in de-energized state. The new valve closes perfectly at the pintle (2).
