Ford Diesel with 2.0L DI, TDCI and 2.4L DI, TDCI, TDE engine from MY 2000 Starter CS1245 or 8EA 737 919-001 Vehicle does not start, starter replacement

Installation instructions: Starter replacement / pasting

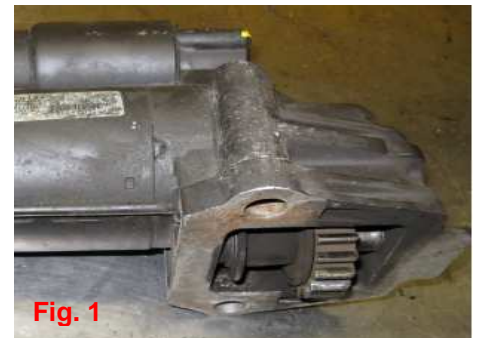
Fig. 1

The above-mentioned vehicles often have the problem that excessive inner soiling (also known as "pasting") can lead to functional failure of the starter. This "paste" is distributed by centrifugal force and magnetism through the whole starter.

"Pasting" occurs on account of dust/abrasion (from the clutch, dual mass flywheel) combining with the grease contained in the starter (armature shaft, roller freewheel).

If you find when removing the old, faulty starter, that the shaft and pinion are soiled by a great deal of clutch dust (black) (see fig. 1), it is imperative that:

- all clutch housing cover plates and sealing plugs are available and fitted properly
- the clutch housing is cleaned intensively and clutch dust, foreign bodies and other soiling is removed completely before a new starter is installed.

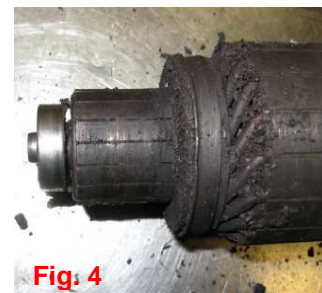
Fig. 4

If this procedure is not observed, the same problems can occur again after only a short time (see figs. 2-4).
