## **Ford Explorer Model year: 1996–1998 Engine: 5.0-litre V8**

### **Refrigerant loss / Accumulator rusted through**

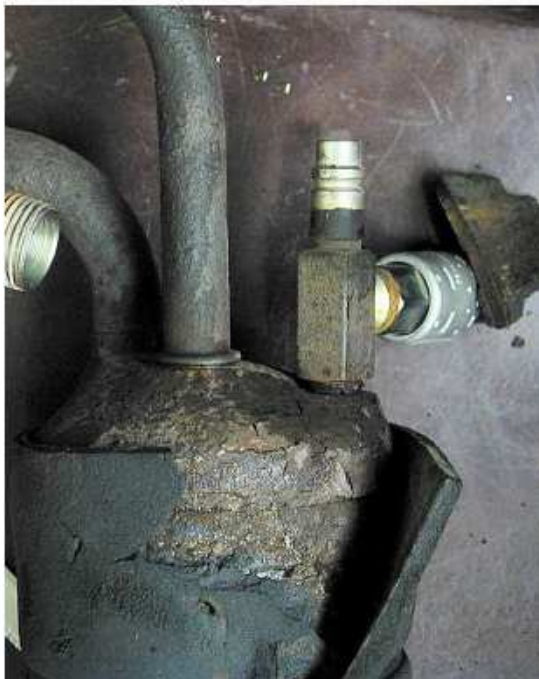
The accumulator is covered in a type of foam which retains moisture, and moisture gets between the foam insulation and the steel housing of the accumulator. Within a few years, this can lead to the formation of very heavy corrosion. In some cases, the accumulator even rusts through.

In the case of the above-mentioned vehicles, particular attention should be paid to the accumulator in connection with refrigerant loss or an air-conditioning service.
