## **Ford Galaxy with automatic air conditioning**

### **Model year up to 01.02.1996**

#### **Poor heating performance**

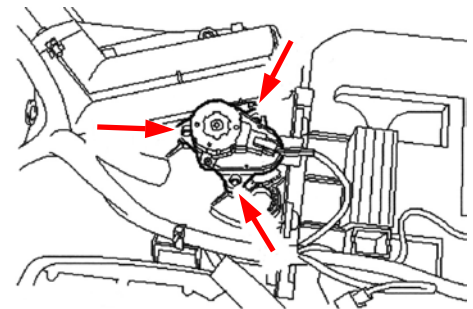
Fig. 1

If there are complaints about the above-mentioned fault, a flap in the heating housing not closing completely could be the cause. To eliminate this fault, the stop on the servomotor for the temperature flap must be shortened by 1.5 mm. To do this proceed as follows:

- Remove the safety cover from the servomotor.
- Remove the screws from the servomotor and take the motor out (see Fig. 1).
- Now remove 1.5 mm from the left-hand stop (see Fig. 2).
- Refit the servomotor and fix in place using the screws. Make sure that the tothing is seated correctly (see Fig.3).
- Refit the safety cover.
- Check the function and heating performance of the system.
