## **Ford / Seat / VW Galaxy / Alhambra / Sharan Engine: 1.9 TDI**

### **Loss of refrigerant / Poor cooling performance / Sudden loss of refrigerant**

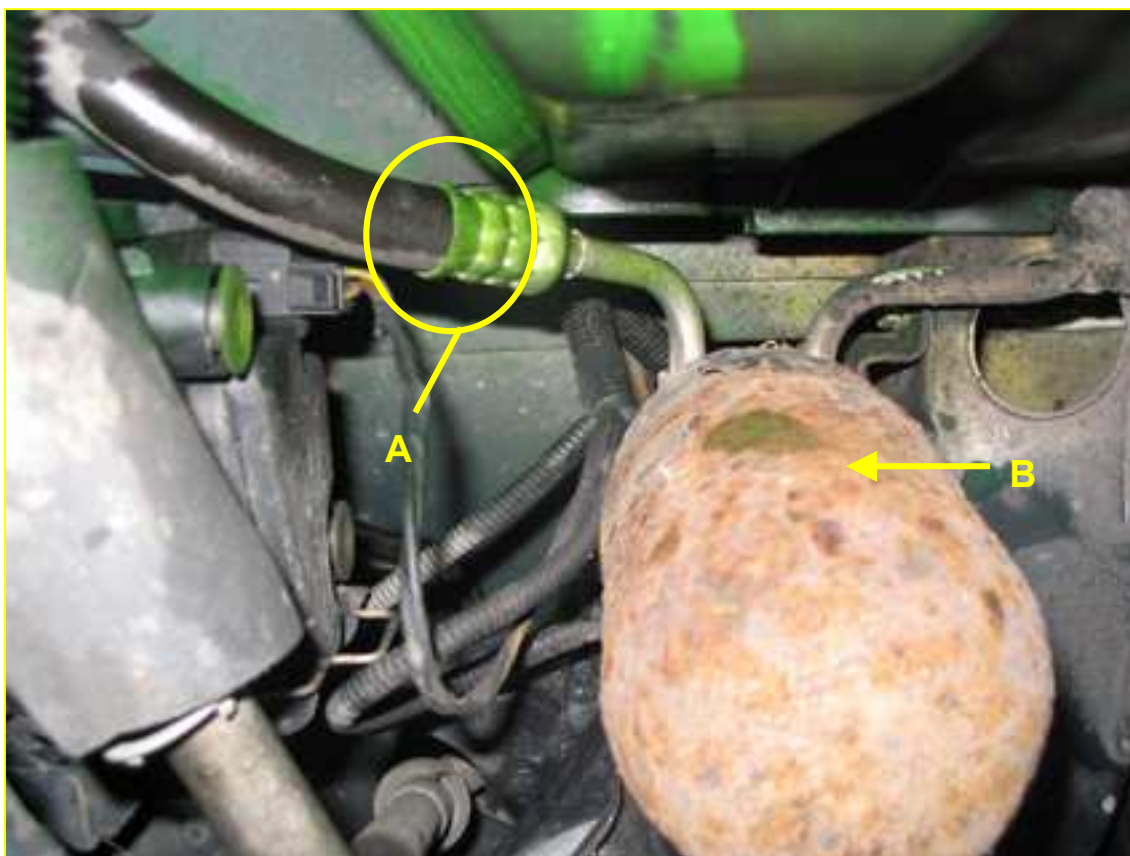
In the above-mentioned vehicles, leaks can develop near the press fittings of the pipe to the dryer (see photo, pos. A). If the refrigerant has been lost completely, particular attention must be paid to the pipelines and crimp connections of the fittings. In this case, the empty air conditioning was evacuated correctly and the vacuum test did not reveal any leaks. The air conditioning also appeared to be airtight after it had been refilled with refrigerant. After the air-conditioning system had been switched on, however, and respective pressure built up, the refrigerant suddenly escaped. This is proof that a completely "empty" air-conditioning system should not simply be refilled with refrigerant despite a supposed leak test having been carried out. Rather, the system should be filled with nitrogen at a pressure of 12 bar first. If this escapes suddenly from a leak spot, this is not only less dangerous for the fitter but also for the environment.

Note: In older vehicles the filter-dryers show heavy signs of corrosion (see photo, pos. B). Such filter-dryers should always be replaced irrespective of their age.
