## **Ford Maverick Up to model year 1998**

### **Overheating of the interior / actuation of heating valve**

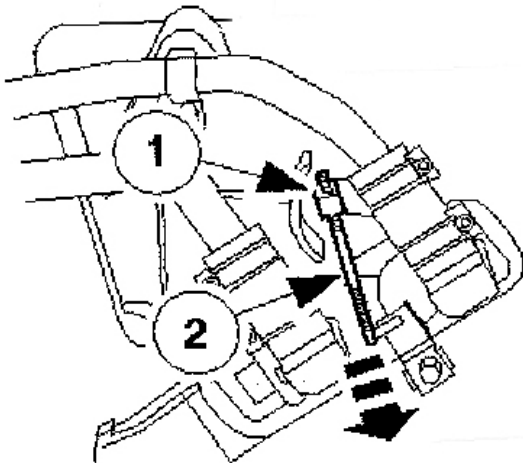
If the interior of the above-mentioned vehicles should overheat with the above-mentioned vehicles or the heating system only delivers hot air, this can be connected to a faulty setting of the actuation device of the heating valve.

- Remove the heating feed and return hose on the thermostat housing with the engine cold (trap the escaping coolant)
- Move the heating slider as far as it goes to "cold"
- Apply max. 2 bar of compressed air to the heat exchanger feed hose
- If no air throughput is established, the setting of the actuation device for the heating valve is OK  
If air throughput is established, the valve is not closing completely. To check/set the actuation device, proceed as follows:
  - Move the temperature slider as far as it goes to "cold"
  - Expose access to heating valve
  - Loosen the clip (drawing pos. 1)
  - Move the actuation rod (pos. 2) down as far as possible (do not move the temperature slider)
  - Replace the clip
  - Check the setting, to do this apply compressed air to the feed hose again.

If no air throughput is established:

- Refill coolant
- Bleed cooling system
