## Jaguar F-Type Model year: 10.2013- Chassis no.: K00103-

### Poor air-conditioning system performance

# BULLETIN

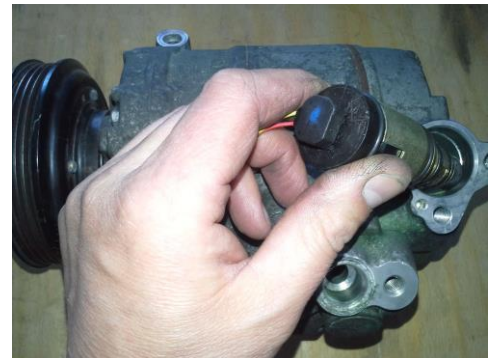
If the customer complains that the cooling power of the air-conditioning system in one of the aforementioned vehicles is insufficient, this may be due to a faulty pressure control valve in the compressor.

A faulty pressure control valve can often be identified by unusual high and low pressure: high pressure too low; low pressure too high.

The figure shows an example of compressor with an electronically actuated pressure control valve

- Drain off refrigerant
- Remove compressor (usually required)
- Clean area around control valve
- Remove circlip from valve
- Carefully remove control valve
- Check the area of the compressor into which the new valve is going to be inserted for damage and soiling
- Moisten the seal rings on the new valve with compressor oil, and insert the new control valve
- Fit circlip
- Fit compressor
- Carry out leak test
- Fill air-conditioning system and perform a functional test
