BULLETIN

Lexus GS300/GS350 Model year: 2006 - 2007

Condensation drain

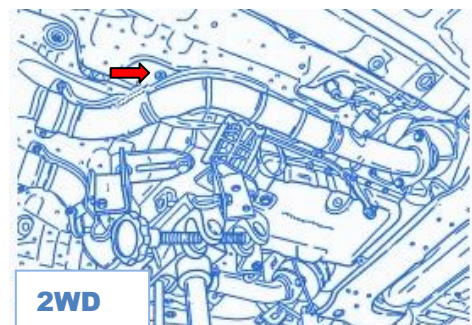
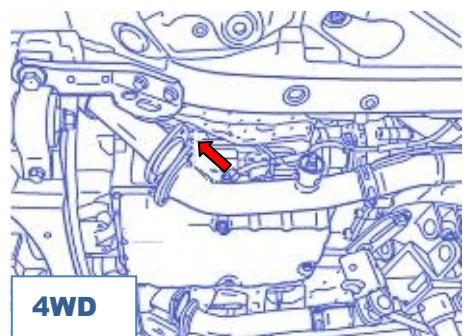
On the above vehicles, a blocked condensation drain in the air-conditioning system can lead to an ingress of water in the vehicle interior.

You can see the condensation drain if you stand on the transmission side and look at the vehicle undercarriage, above the transmission (see drawings).

You can now clean the grommet for the condensation drain using a long, blunt object or replace it with a modified version. For more information, please contact your authorized dealer.
