Mazda 626 IV (GE) Build year 1991-1998 with factory installed air-conditionung

Leaking condenser

Bulletin

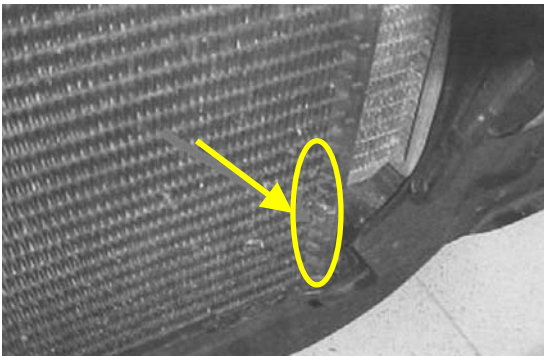
On some of the above -mentioned vehicles a leakage on the condenser can occur. Often the leak is in the lower area. If a refrigerant loss is established, it's recommended to spray this area with a leak detection spray (see picture). Alternatively the leak detection can be carried out with an electronic leak detector or a contrast medium (dye).
